<p>Wildland-Urban Interface Virtual Essays Workbench</p> <p>WUIVIEW</p> <p>GA number 826522</p>	 	  <p>Funded by European Union Civil Protection</p>
---	---	--

Technical Note

Wildfires in 2020

Forest Fire in Eurovillas - Madrid (Spain)

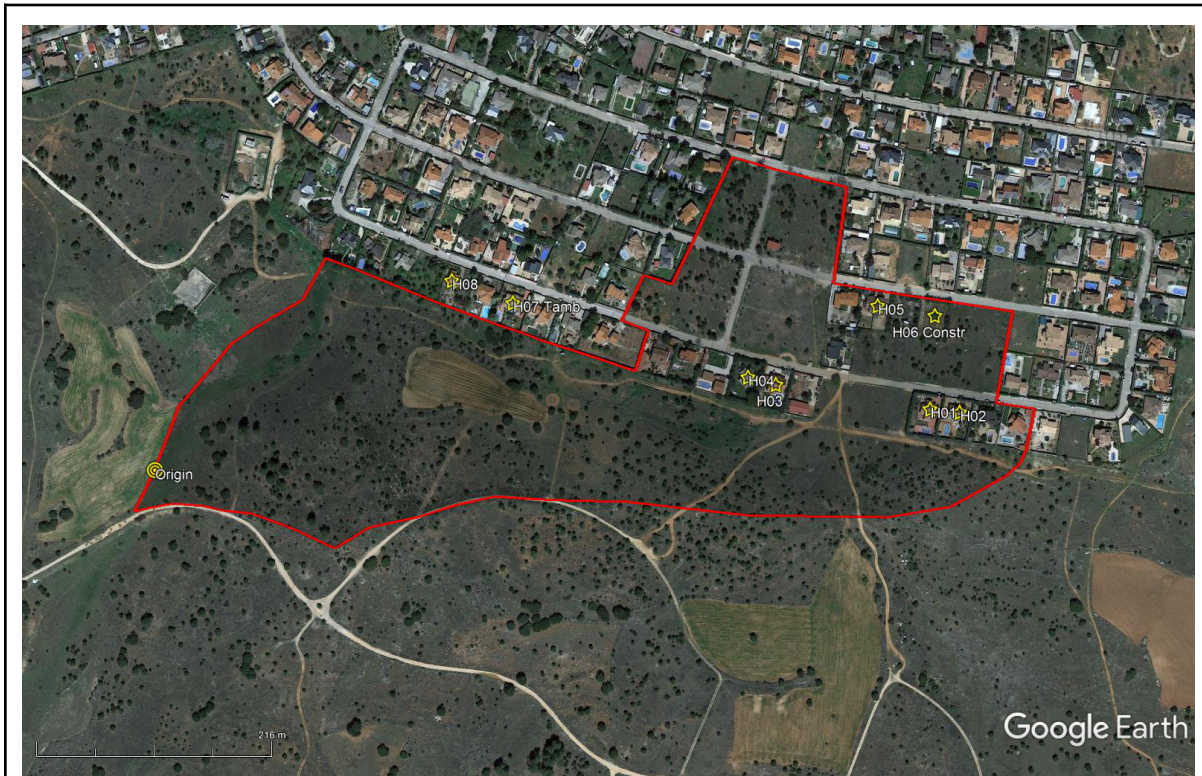
A general view of the fire perimeter spanning over 14.9 hectares and presenting the origin, the main spread axis and the impact zone. Most of the lots had green hedges with flammable species.

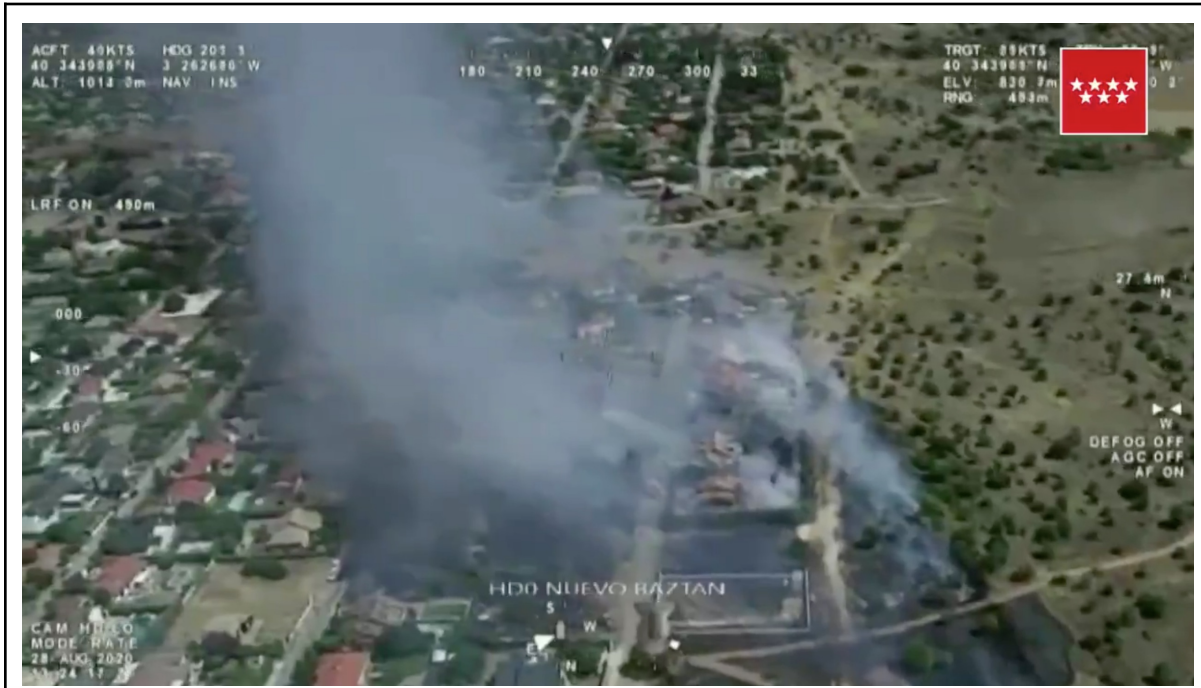
An aerial view of the propagation inside the first and second rows of houses in the settlement, by the time the first aerial means arrived in the area. Note the intensity developed by the gardening elements, more particularly flammable green hedges, and some objects and materials involved, including some vehicles.

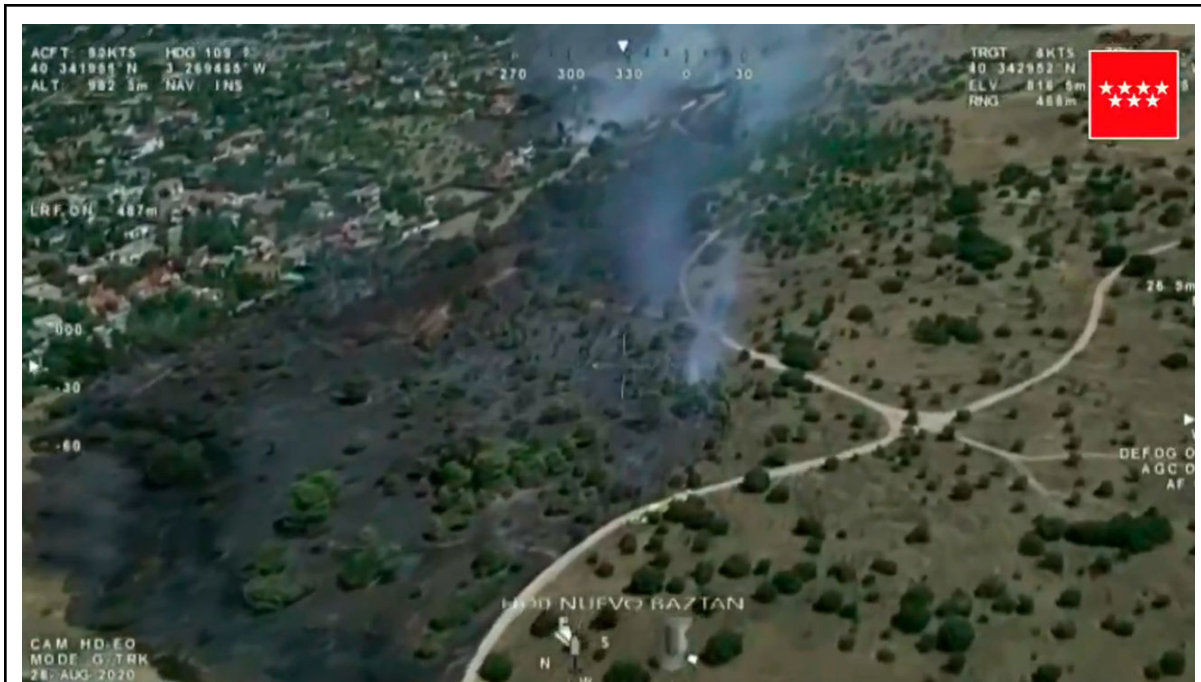
An aerial view of the final stages of the fire propagation, which continued inside the settlement through green hedges and gardens.

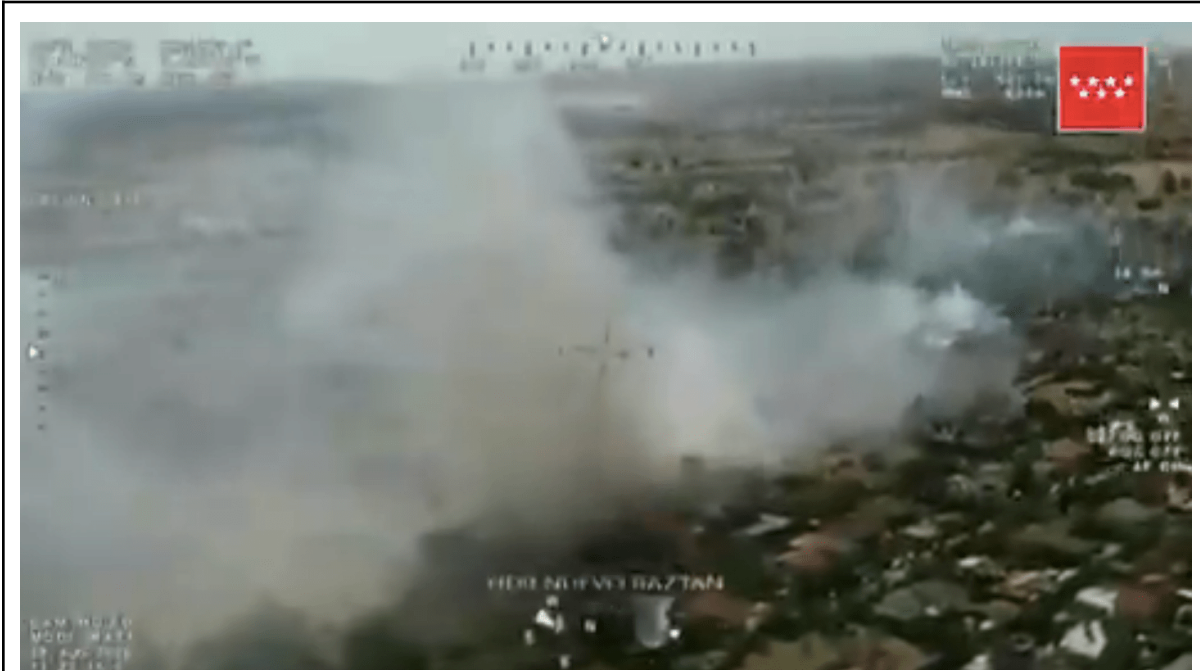
An aerial photo showing the behaviour of fire propagating inside the first two rows of properties, in particular note the intensity developed by green hedges.

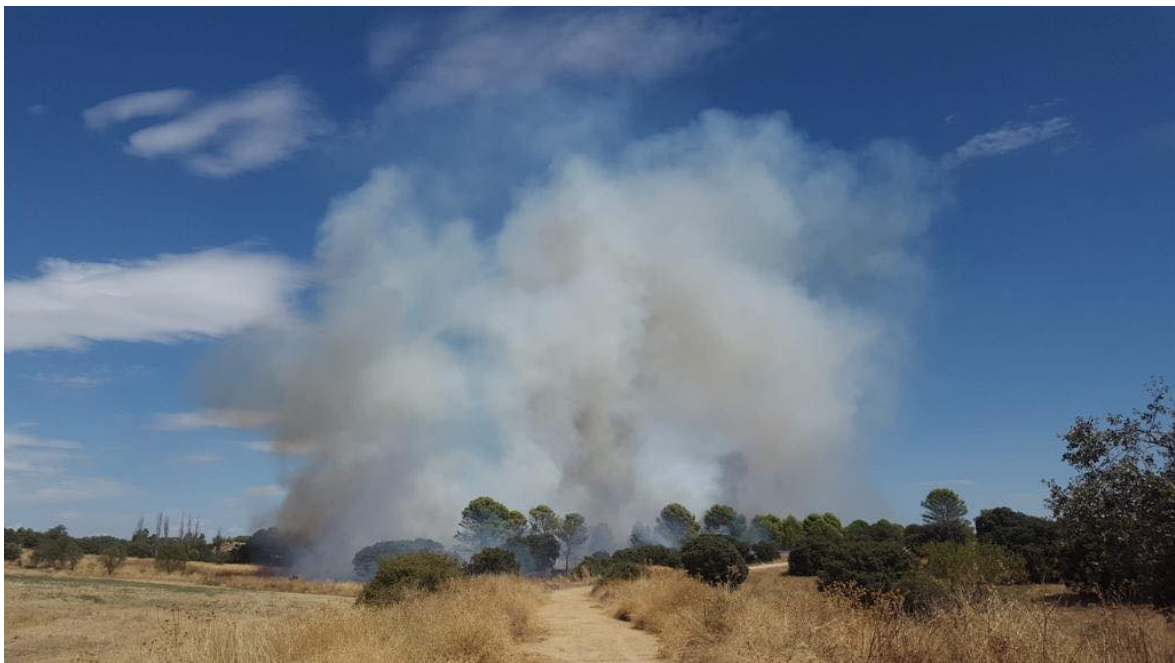
The fire propagated mostly through tall cured grass and sparse vegetation, showing a medium intensity and high spread rate. Once inside the settlement the intensity tripled in some points, due to the flammable garden elements, producing thick and intense smoke.

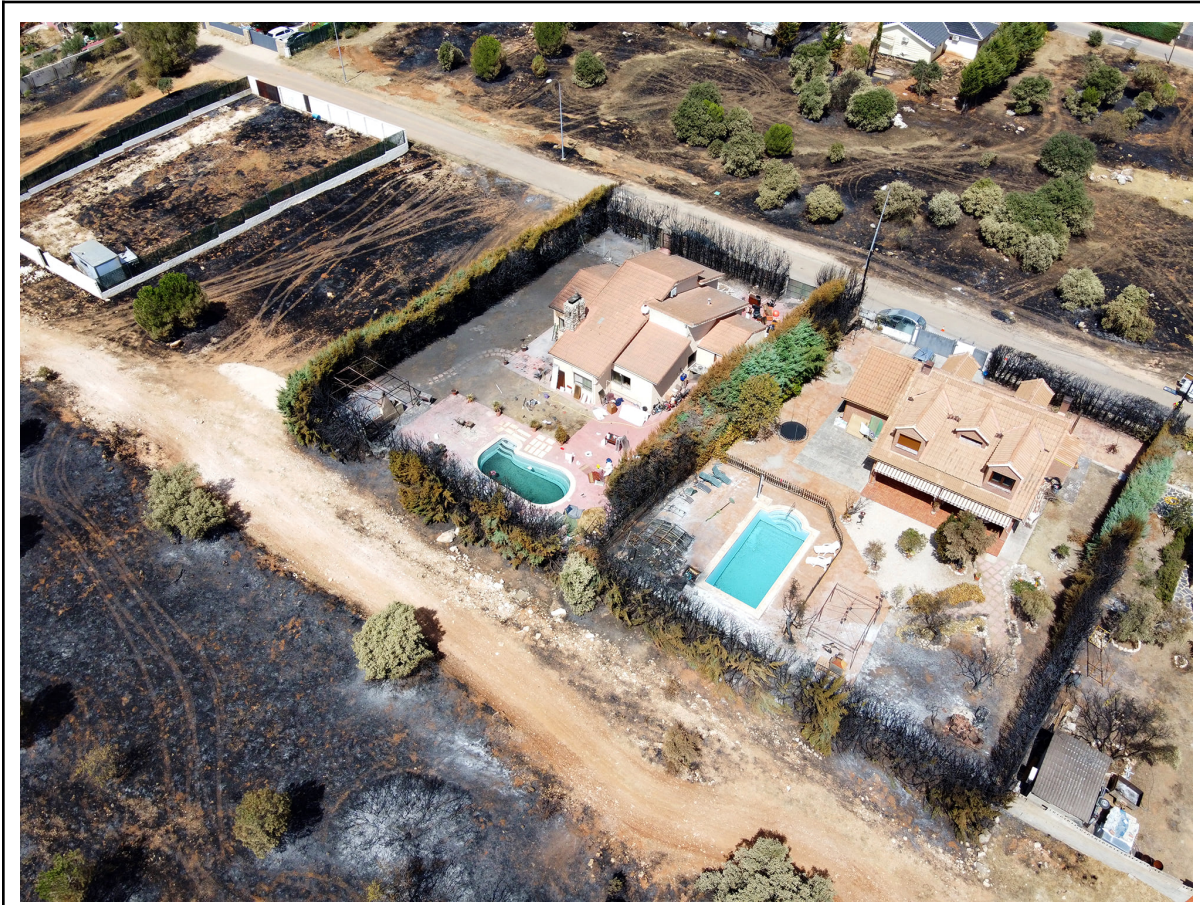
This drone picture shows a general view of the impact of fire front in the first rank of houses and green hedges. It is observed the role of these hedges in propagating the fire inside the settlement and how they contributed to the ignition and combustion of other objects and materials, such as pergolas and green houses (in the left-South corner of each parcel) and the affectation of houses. The angle formed by the main axis of propagation is clearly visible (wind blowing from WSW). In case of a wind blowing straight from the South, most likely the fire penetration could have been much more effective, through green hedges and gardens, complicating noticeably the whole event. The East limit of the community presents higher fuel loads and in case of a South wind, it is expected that the fire front could have increased the intensity even more.

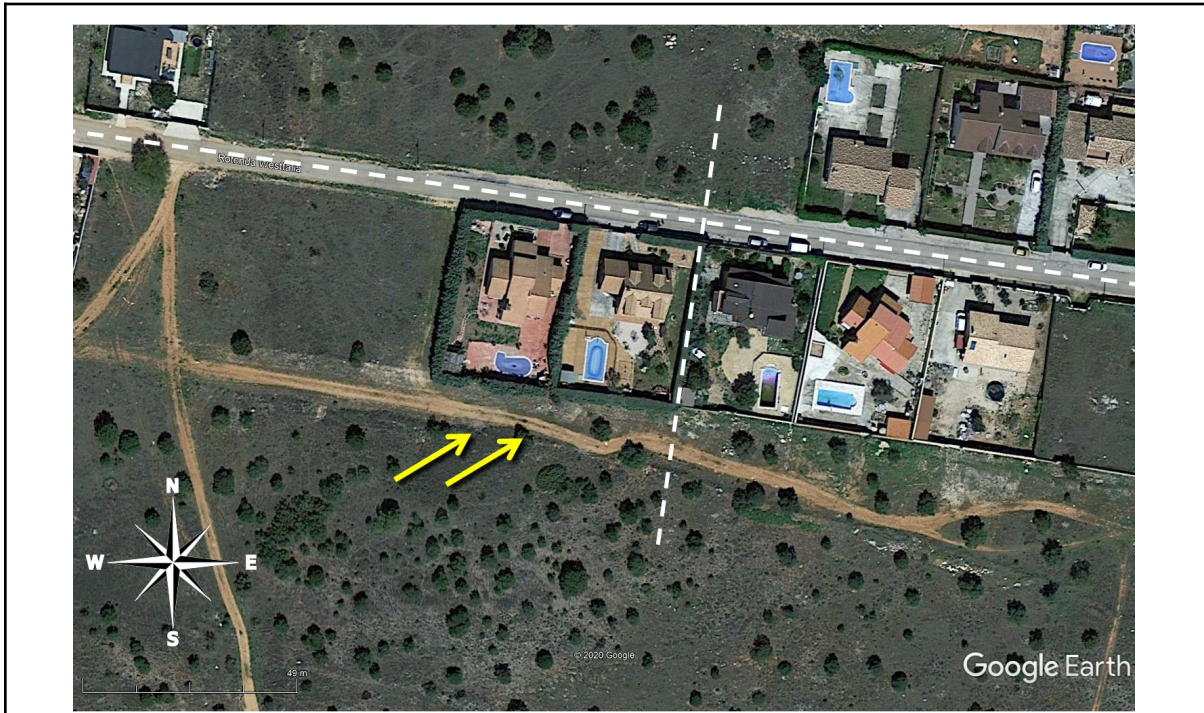
An orthophotography showing some of the lots receiving the impact, the involved angles and the main axis of fire propagation (in yellow). As observed, the main impact took place in the front-left flank, a fact that partially reduced the penetration of fire and the associated consequences over gardens and buildings.

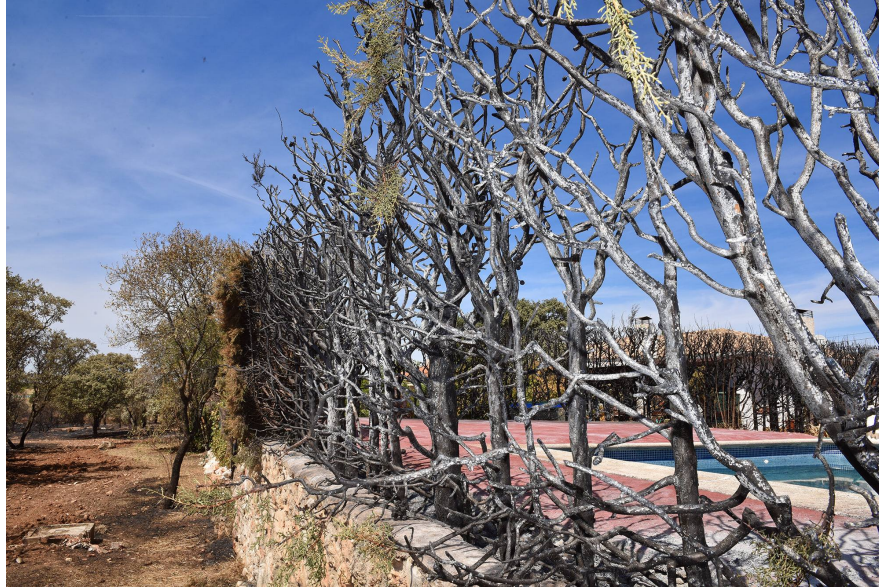
A close view of one of the affected green hedges, receiving the main impact of the left flank. Observe that a separation from the forest fuels was in place, in which the fire reduced intensity. However the flames managed to initiate the combustion and propagation over the garden vegetation.

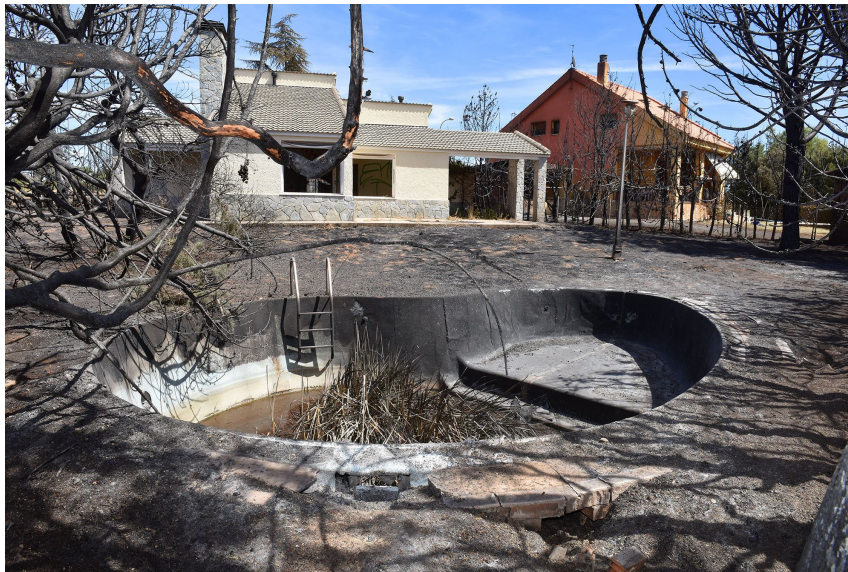
One of the lots affected was abandoned, with a considerable amount of dead vegetation all across the garden, including the pool. The parcel was enclosed by a tall, unmaintained hedge of Cupressus arizonica, which burned very efficiently, propagating the fire and affecting the neighbouring house.

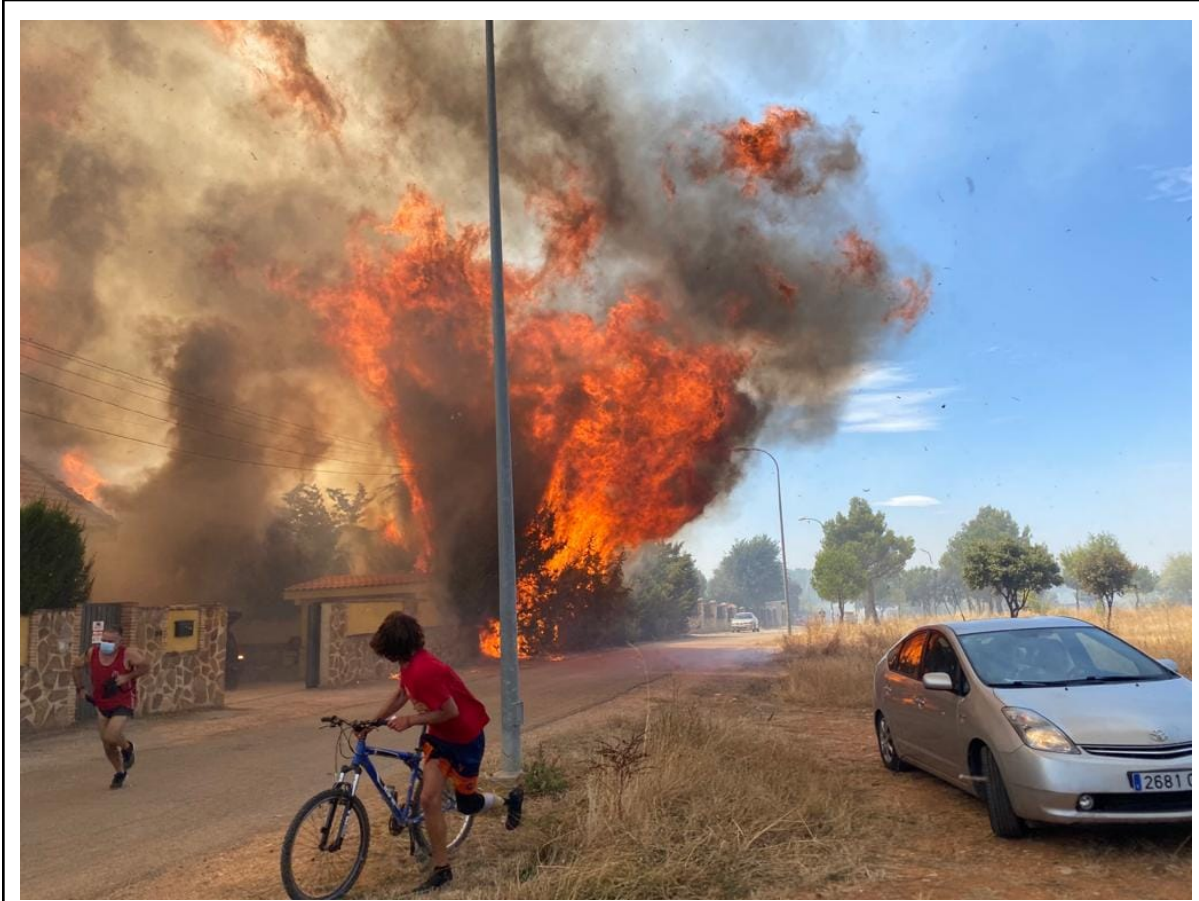
Picture taken in the same street, from portal number 96 and wind blowing towards the camera. Observe the intensity of the green hedge burning at maximum intensity. The other land plots were covered with cured, very flammable tall grass, which easily started new spot fires after the hedge propagation projecting flying embers. People stayed taking pictures and moving the cars, helping with garden hoses and water buckets, ignoring the potential risk of a fire in the grass-covered lot encircling them. A lot of effort was put by residents on the garbage bins to avoid their ignition. A car is just turning in the grass field, another one is waiting for the fire to subside. As seen, people are taking part in the event, although they mostly ignore the potential risks. No one was injured.

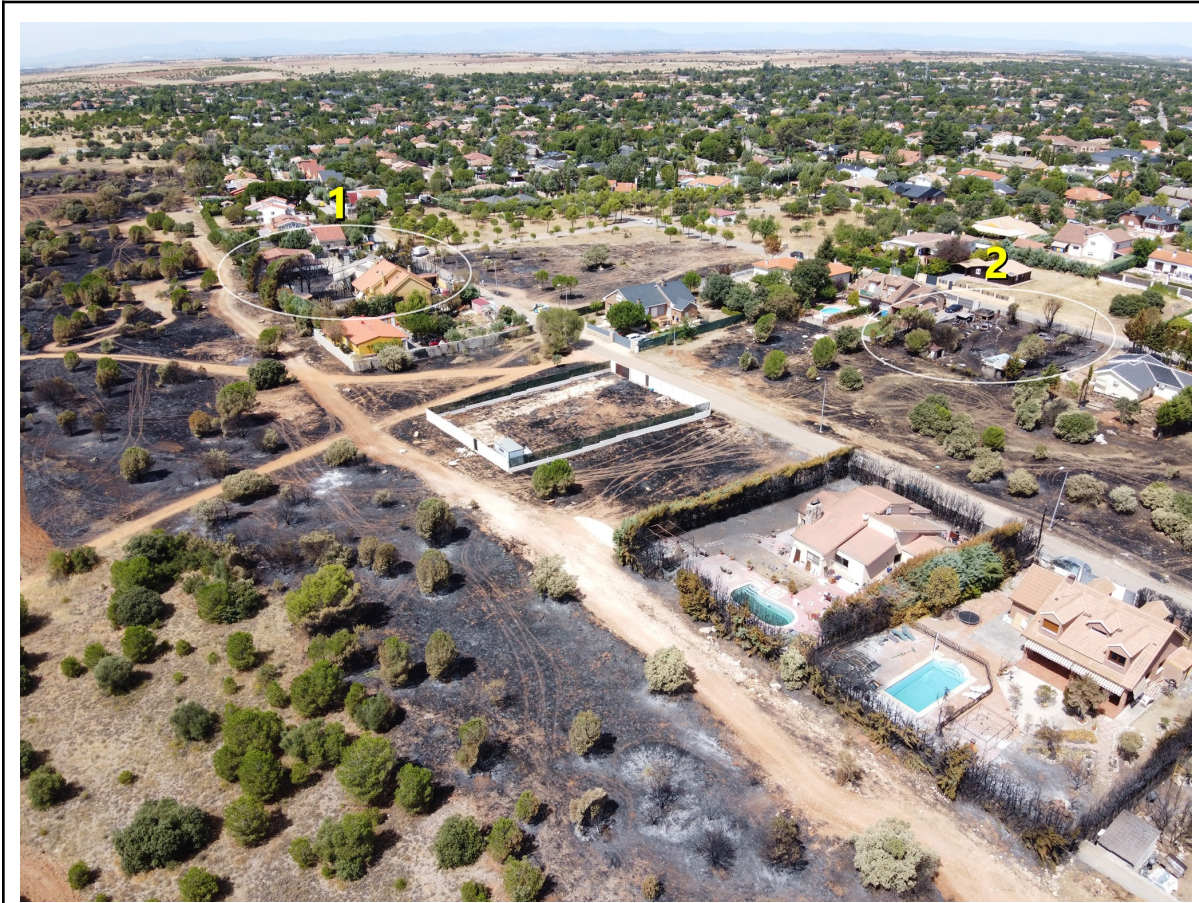
In this general aerial view, we observe the abandoned lot (1) which was firstly affected by the fire front impact, and the further effect on the flammable green hedges, and a second abandoned lot (2) with some vehicles in it, which received the fire propagating from the previous one over the undeveloped lots covered with cured grass. This image clearly shows how the presence of continuous flammable vegetation in abandoned or undeveloped lots is a key factor for the fire penetration within the settlement. Also, how the presence of vehicles, sheds, warehouses, greenhouses, garages and any other place in which there is accumulation of machinery, fuels, other flammable materials and objects contribute to the escalation of risk in the fire event, originally a medium-intensity forest fire. The starting point lays approximately in the upper left corner of the photo.

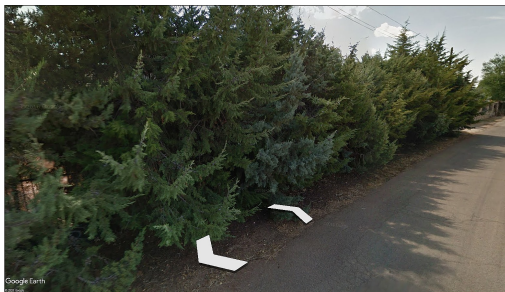
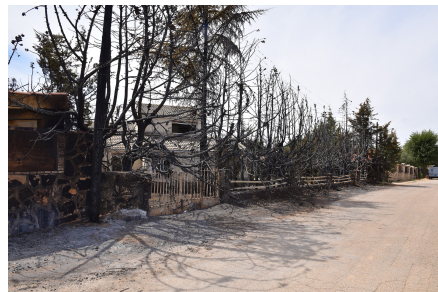
The North limit of the first abandoned lot presented an overgrown flammable hedge, covering all perimeter including the access gate, which was occluded. This is the before (left) and after (right) of the same location.

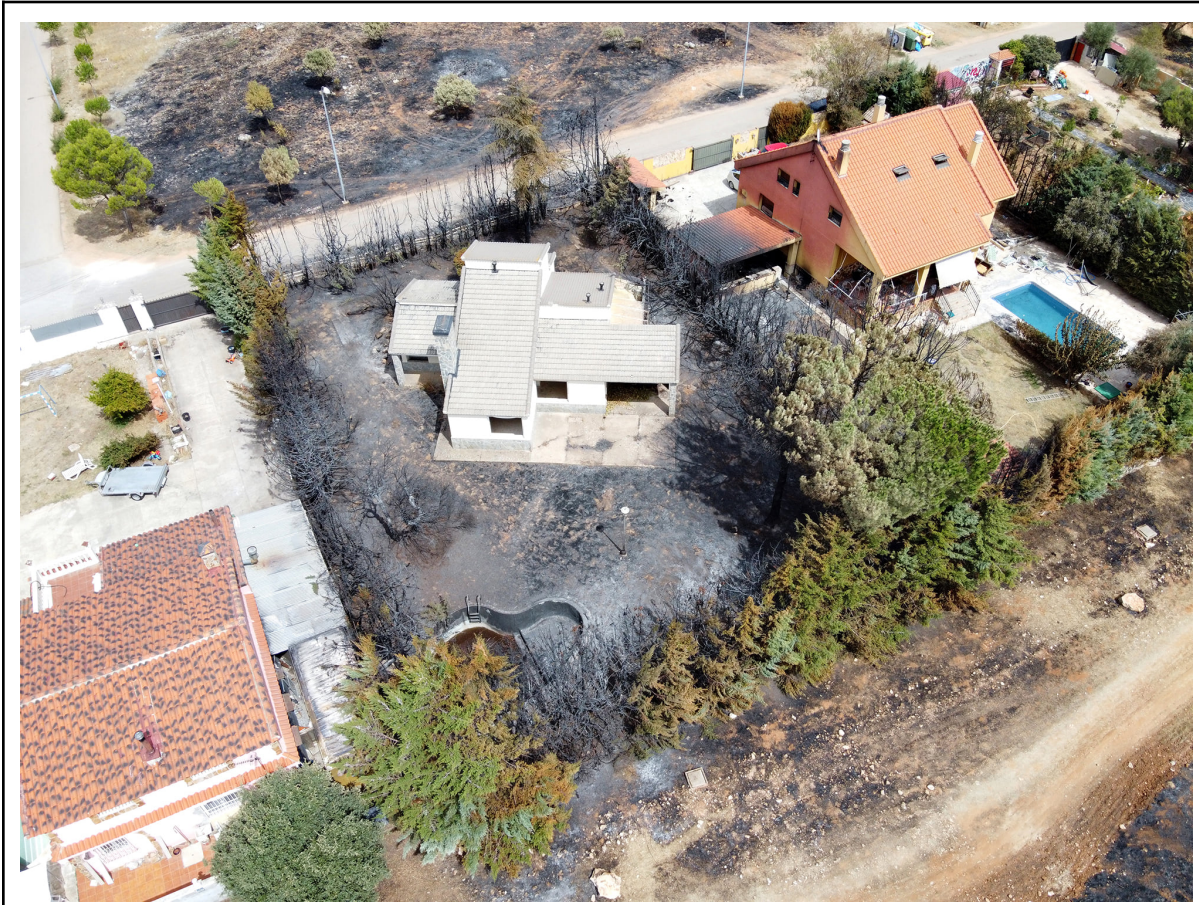
The first abandoned lot (1) presented an overgrown hedge without any trace of treatment over several years, accumulating fine dead fuel in all extension. The house was not affected, as no objects were inside and because it was erected with unburnable materials. However, the neighbouring lot, the garage and the house was affected by the combustion of the green hedge, creating a high intensity flame which firefighters barely could suppress even with aerial means (helicopter) present in the area. Also, appreciate the effective spotting in the lot opposite and how this developed a new fire propagation towards the interior of the settlement.

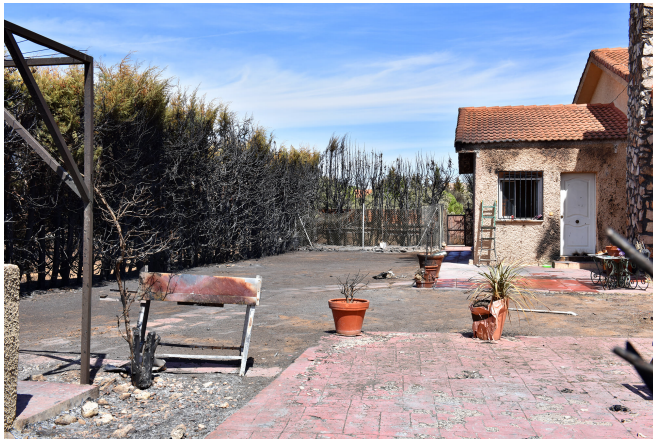
A view of another lot affected in this event. The combustion of this corner (left), and the greenhouse present, was initiated and consolidated by the combustion of the green hedge. The developed flames affected the closest façade of the building, entailing the entrance and partial destruction of the corresponding room. Practically all of the houses affectation was due to the combustion of the surrounding vegetation, in particular flammable green hedges.

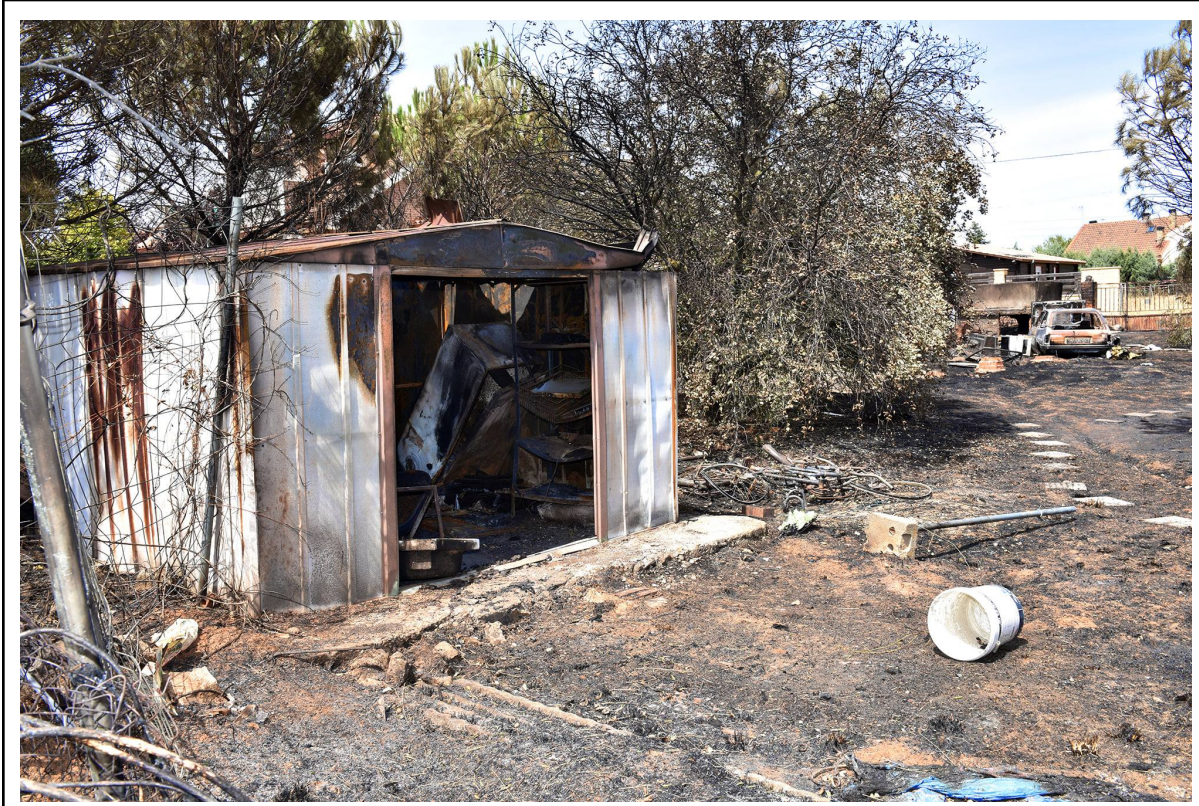
The presence of garden sheds and small warehouses represent points in which the fire frequently involves other materials and objects, thus increasing the intensity in a semi-confined combustion. Observe also that even with a low to medium intensity fire, such as this propagating over cured grass in an abandoned lot, all vehicles and small structures are vulnerable to the pass of the flames. These situations frequently demand attention and resources from firefighters to avoid and escalation of the risk in the emergency management. For example, some gas canisters were found exposed to the flaming and post-frontal combustion which, eventually, may pose a risk to firefighters operating in the area.

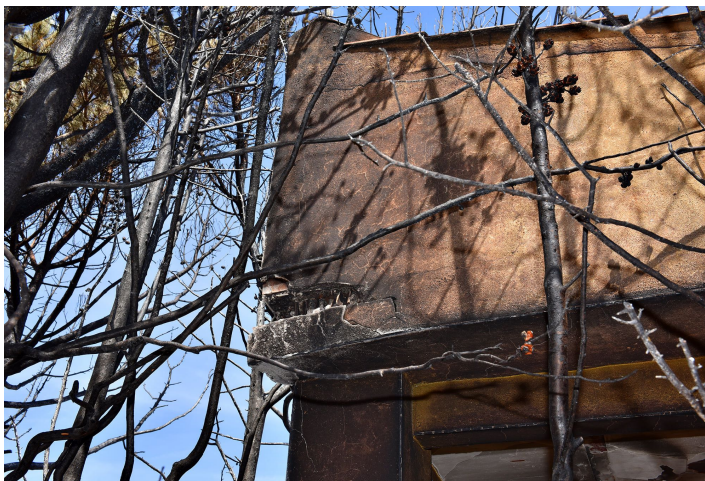
Flame impingement in the structures was observed in the places where vegetation was touching or surrounding façades. The effects were more noticeable in the corners and hedges, as in this case. Heat dose was enough to initiate the destruction of masonry and insulating materials.

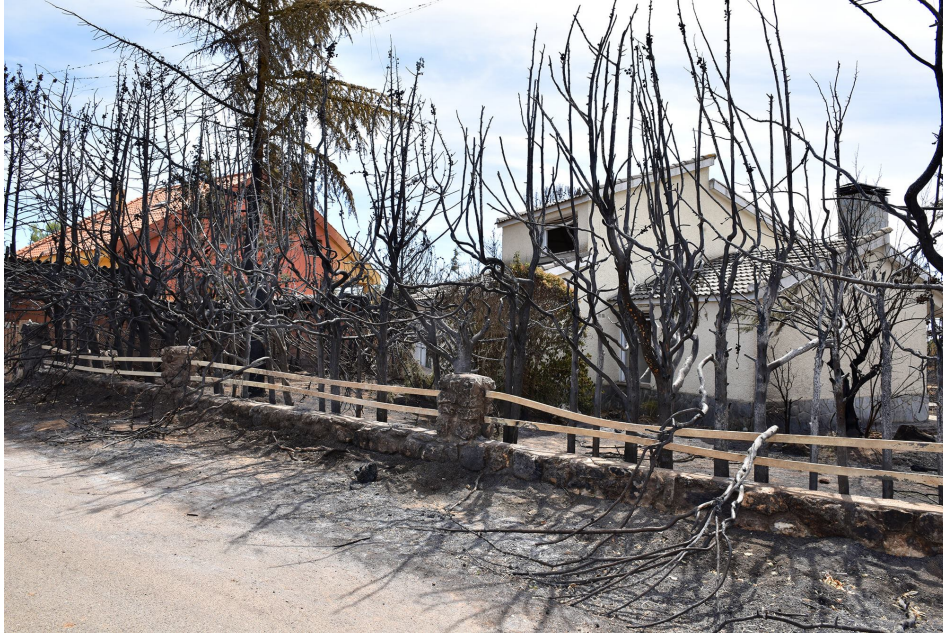
A view of the North limit of the abandoned lot. Observe the combustion efficiency over the flammable green hedge. No fire fighting operation was performed at this point. The helicopter was assigned to the suppression of fire in the front and to the control of the propagating flames inside of the other abandoned lot, in which several vehicles burned.

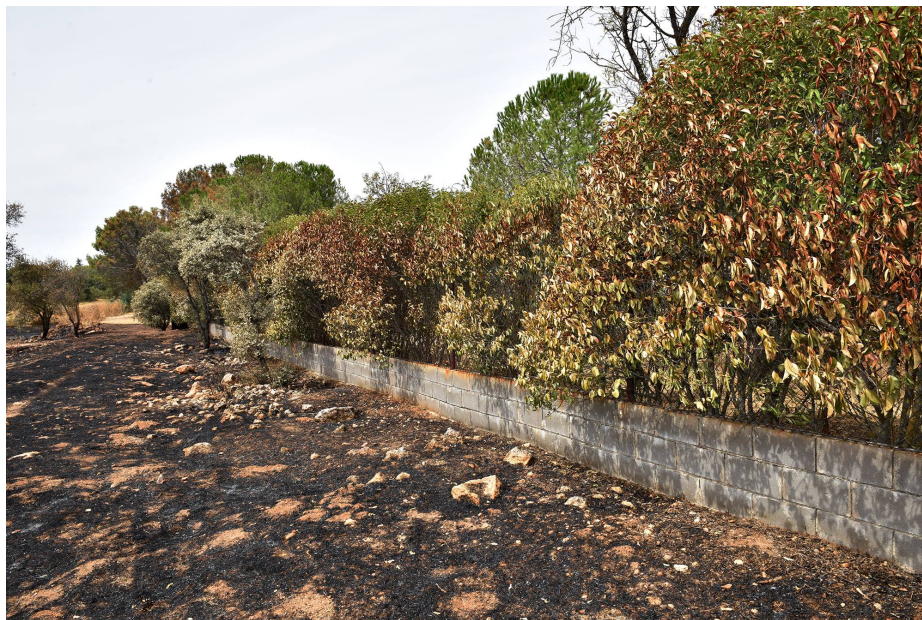
Observe how the presence of a small wall (70 cm) and fire-resistant plants in the lot hedge contributed to reduce the likelihood of the fire jumping inside the parcel and spreading the propagation into the settlement. This is a good example of a proper fire-adapted design of gardens.

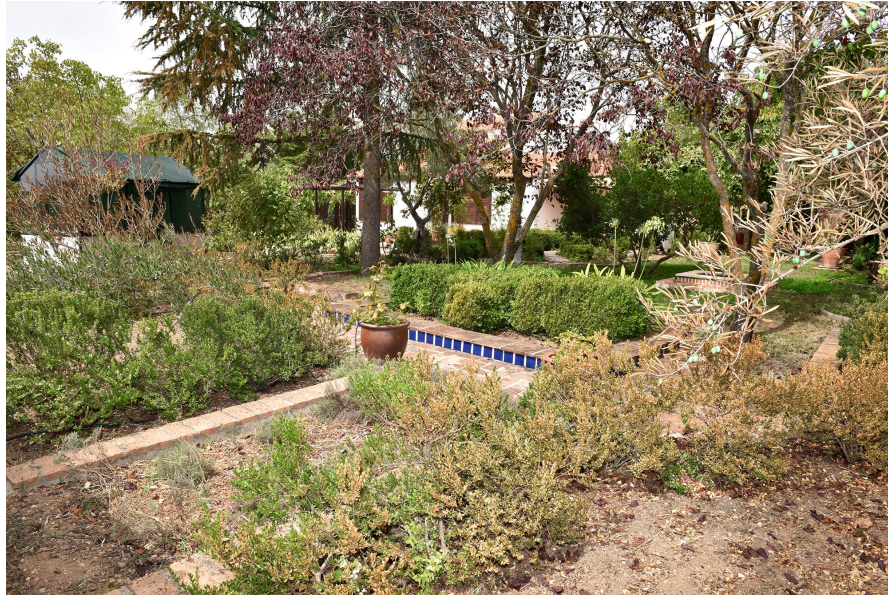
A view of the garden of the lot next to the previous one, also with a wall. Observe the lack of vegetation horizontal continuity, the presence of watered soil and fire-resistant vegetation, which contributed greatly to stop fire propagation. The plants are charred, but did not propagate the fire. This is a positive and very graphic counterexample of the flammable species found in other lots in the same fire event.

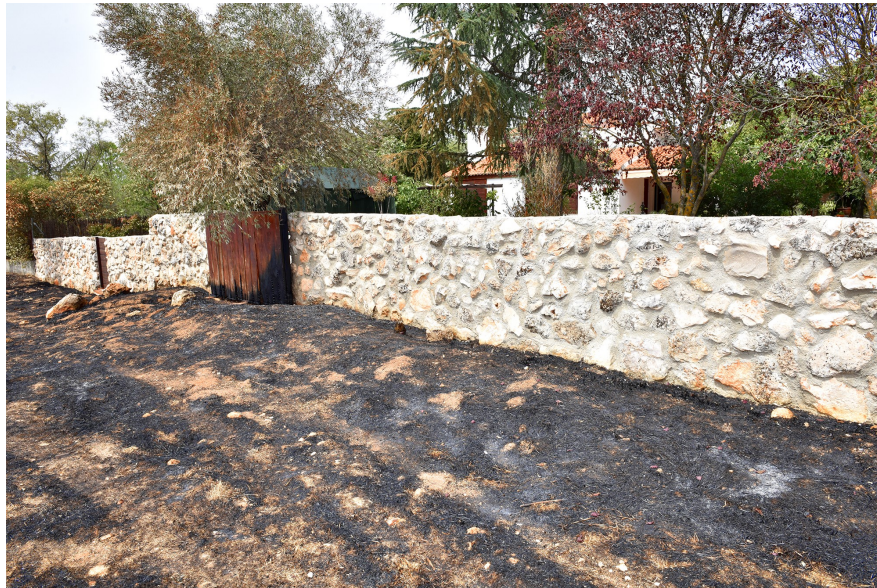
The wall encircling the lot, about 1 m tall, was very effective receiving the flame impact of the surface-propagating fire over the cured grass. This is a very effective design in which the exterior (wall) and the interior of the garden work together to stop the fire and minimize consequences. This should be an example to follow in the rest of the lots in contact with the wildland. It is very clear that lots in the perimeter loaded with flammable vegetation and other materials and objects represent a threat to the rest of the community, as in these points the fire increases intensity and initiates the projection of flying embers. The presence of flammable hedges and undeveloped lots with cured grass in the interior of the community,

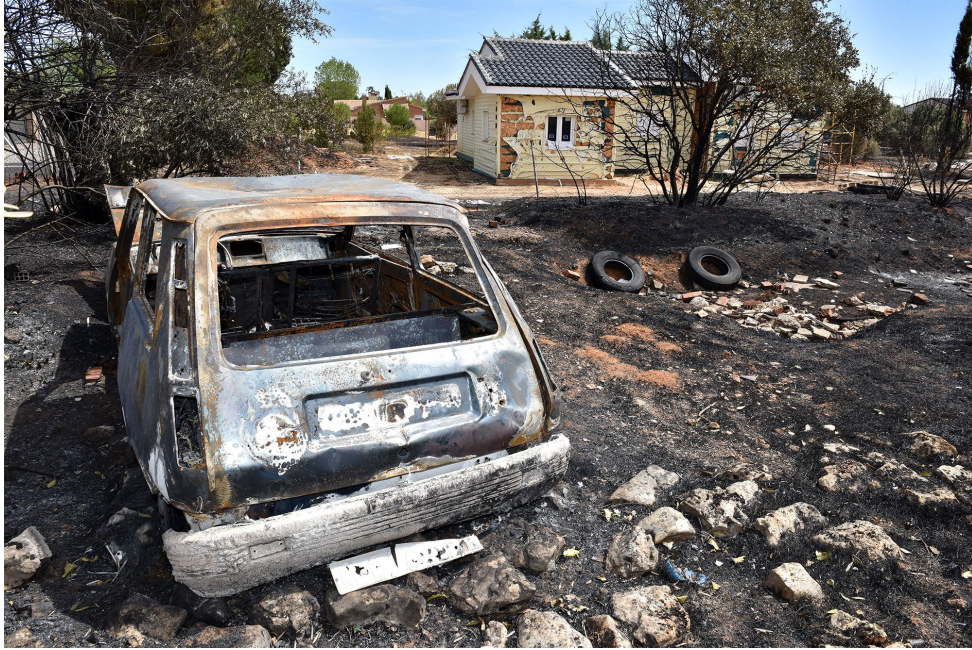
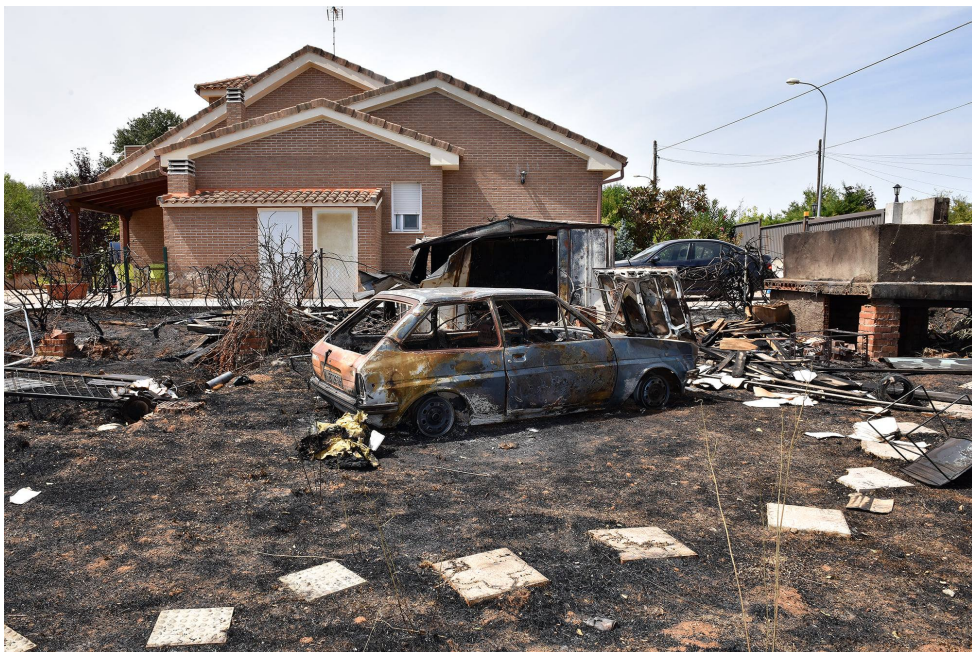
Another undeveloped lot, with an abandoned vehicle which was engulfed by flames and created local high intensity combustion, which was attended by firefighters. The presence of a house under construction, with plastic elements in the façade, and a second residential house in the other side, pushed fire fighters and residents to take part in the suppression of this particular lot (see picture below)

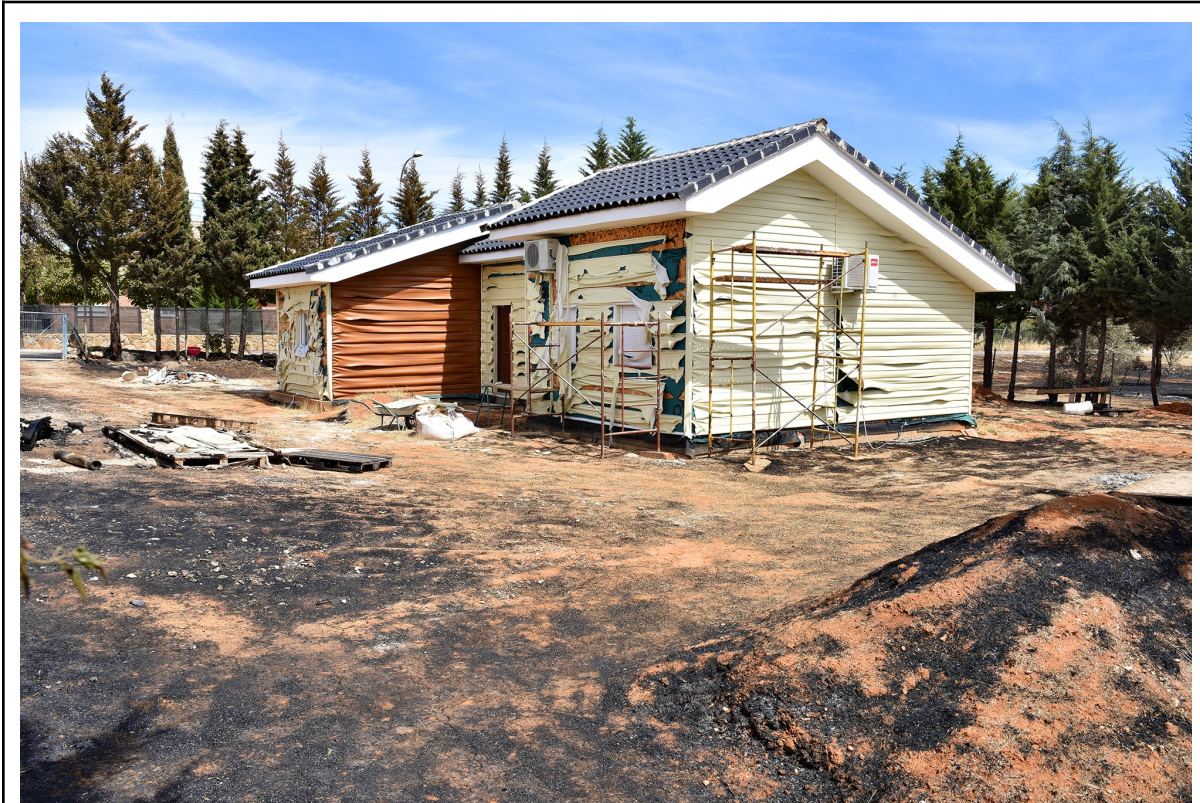
A detail of the house under construction that was noticeably affected. Despite the relatively low fuel load in the lot, the presence of other materials, objects (including gas canisters) and vehicles, complicated the overall operation, in which residents took part voluntarily. This aspect is repeatedly observed in wildfires affecting WUI areas, in which fire fighters are overwhelmed and citizens take over the suppression activities, ignoring the risks they are facing, including chained events (such as combustion of highly flammable products, production of toxic gases or explosion of canisters).
