Wildland-Urban Interface Virtual Essays  
Workbench  
**WUIVIEW**

## Deliverable D7.2 Report on case studies

<b>WP - Task</b>	WP7 – Tasks 7.2 and 7.3	<b>Version <sup>(1)</sup></b>	Final
<b>Code (file name)</b>	D7.2_F_WUIVIEW_Report on study cases	<b>Dissemination level <sup>(2)</sup></b>	Internal
<b>Programmed delivery date</b>	31/01/2021	<b>Actual delivery date</b>	31/01/2021

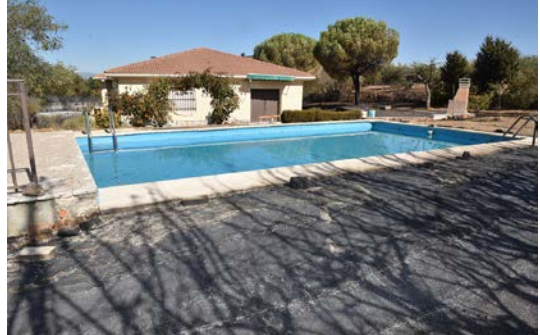
<p>General view of the property from the East bound, in which a large piece of land includes a pool and a few ornamental plants. A green edge of flammable species (<i>Cupressus arizónica</i>) burned almost completely. Two pines (<i>Pinus pinea</i>) were just scorched by the combustion of the green hedge.</p>

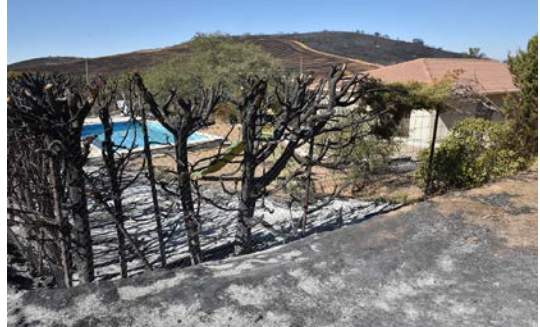
<p>The line of green hedge enclosing the property was almost completely burned. Beyond limits, there were just laboured agricultural fields. The owner of one of them said that most of the olive trees would die, although they were just scorched by the passing fire over the cured grass.</p>

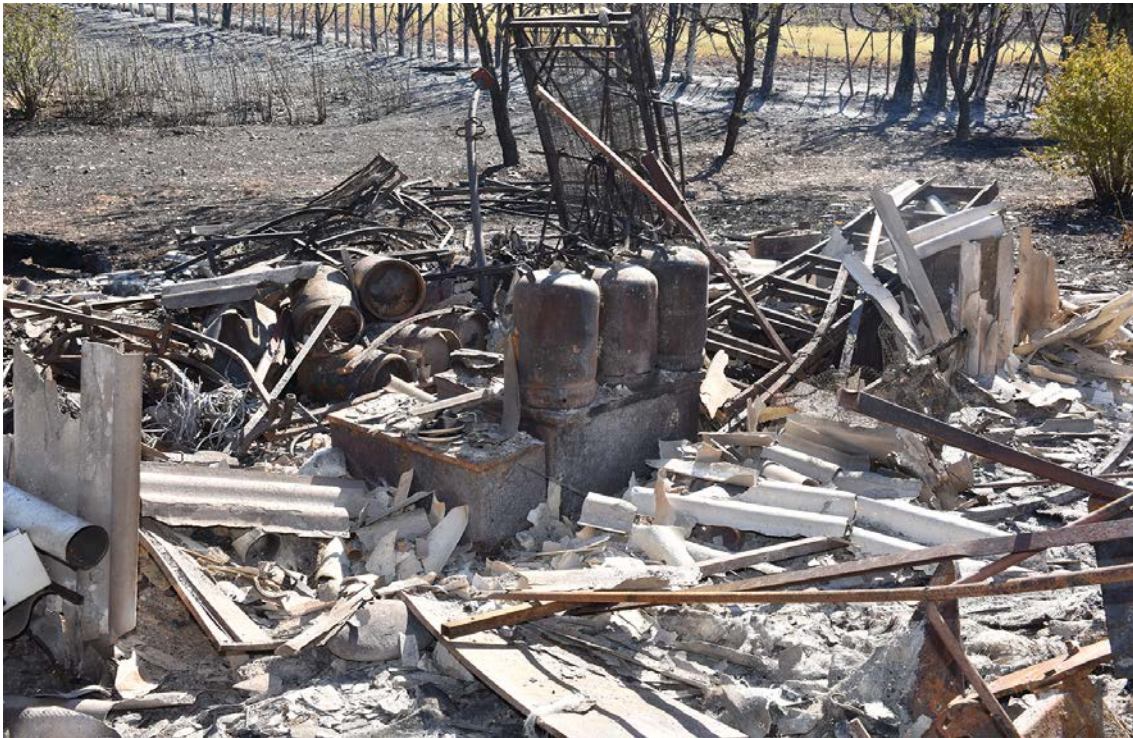
The final scoring in this case is **35/45**. The final scoring well reflects the reality in a forest fire, as observed. The main drawback in a sheltering operation in this case is the presence of old persons with walking difficulties who could suffer consequences. Besides, the lack of specific equipment could lead into some accident, particularly trying to put out fire of the burning flammable green hedges. Besides, the old house, not far away from the main building and used as warehouse, was a real source of potential danger, as it was engulfed by flames and many objects and materials, including several gas canisters, were exposed to fire. In general, the SAT evaluation is very appropriate and accurate to what was observed (Figure 9).

*Figure 9. Gas canisters exposed to the combustion of the old house, near the main building.*

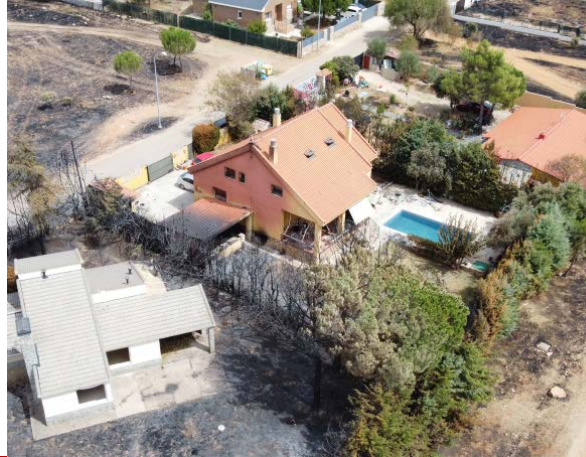
<p>General view of the West façade, mostly affected by the burning materials and vehicles present in an open garage, connected to the underground floor through windows which let the fire pass into and destroy several rooms. The open garage was ignited by the burning green hedge in the neighbouring plot. The fire managed to jump into the plot at the North and progress over grasses.</p>
 	<p>View of the South façade and the trajectory of the fire, from the green hedge to the open garage and then the house.</p>

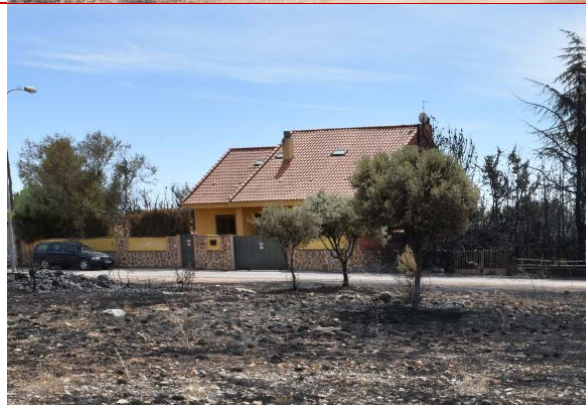
<p>A view of the North façade from the neighbouring plot covered in cured grass that burned very quickly. Note the high intensity of the fire in the green hedge at the right.</p>

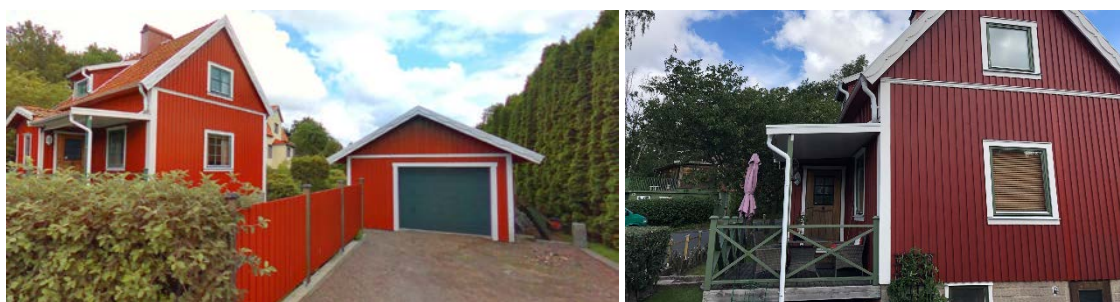
The timber building has never been exposed to wildfire. The main reason for selecting it is the very large *Thuja occidentalis* hedge marking the boarder to the neighbouring property (Figure 10). The building across the street is adjacent to a forested area with mostly conifer trees and a very steep slope against the buildings studied here.

Figure 10. Photos of the property with a hedge selected for the Scandinavian VAT testing.

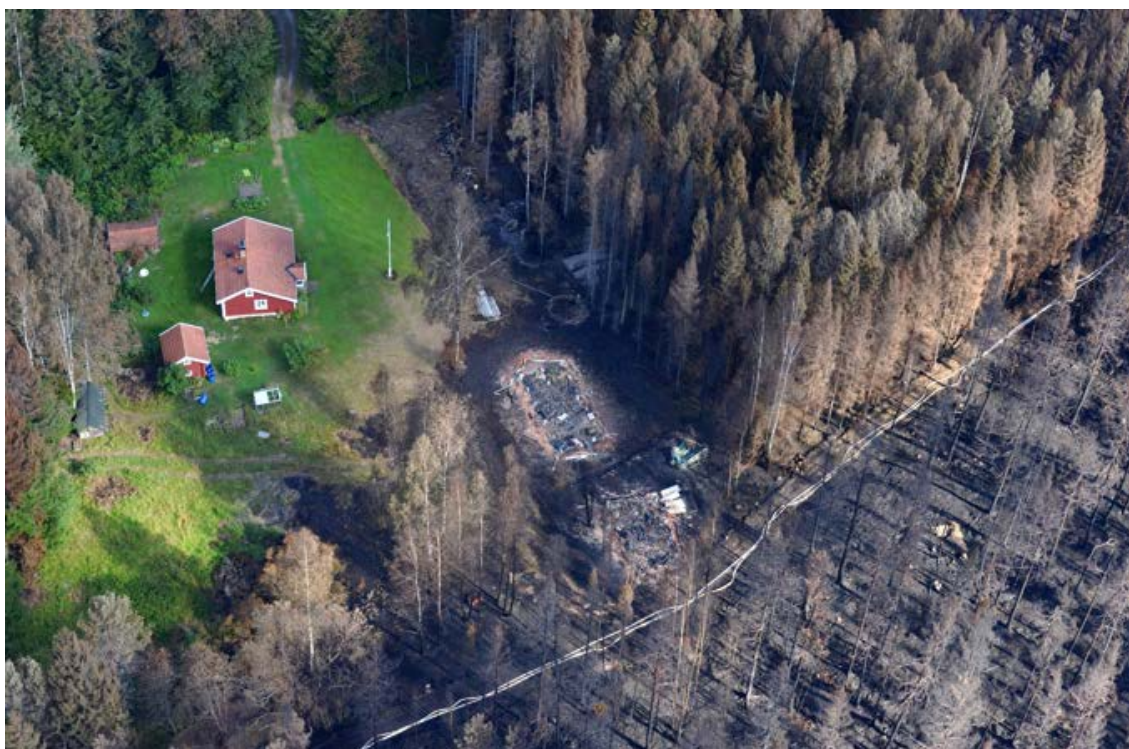
The second building survived the Västmanland fire 2014 with the help of the rescue services. The property is mostly surrounded by conifers and a high intensity fire raged just passed it. Two outbuildings with very close distances to the conifers were ignited and burnt down while the main building and other outbuildings were saved by the managed lawn at which the fire stopped (Figure 11).

Figure 11. Photo of the structure from the Västmanland fire that was selected for VAT testing.

Filling out the questionnaire for this property yields a score of 38.5 (Table 11). The property is threatened by the large portion of conifers surrounding it and the combustible timber façade of the house. The property as a whole is instead protected by the well-maintained lawn surrounding the whole building, the absence of a porch or semi-confined space as well as little fuel next to the façade. One can imagine that significant ember production occurred while the crownfire was ongoing and the outbuildings were burning. It is evident that the situation was a close call for the building since the ground just to the left of the closest outbuilding was scorched. If the outbuilding had ignited the house would have been seriously threatened. However, the very low intensity and inability of the lawn to transport the flame front saved the house this time.

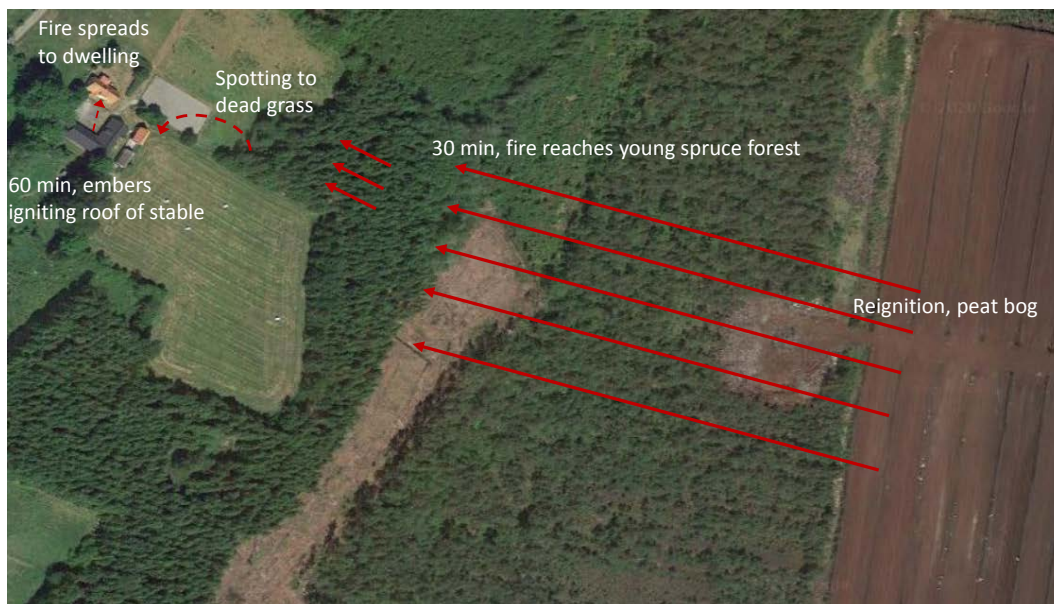
This day the wind speed was 7 m/s on average with gusts up to 20 m/s. Thus, the fire spread rapidly to the nearby regeneration forest with low-crown-height spruce which, in turn, burnt in the canopies generating embers in the strong wind (Sjöström et al, 2019). The embers spot-ignited dead grass from last season on the farm which were efficiently extinguished by the farm employees. Eventually an ember landed under the tiles on the edge of the ceiling of the stable. The whole roof was thereafter in flames within minutes and shortly after the large fire in the stable spread further to the dwelling (see overview in Figure 12). All buildings were completely burnt down but luckily no people or horses were hurt (Figure 13). The final burnt area was 160 ha and additionally 15-20 buildings were severely threatened by the fire but could be saved by the rescue service.

Figure 12. The fire spread from the peat bog to the horse farm in Skåne, 2019.

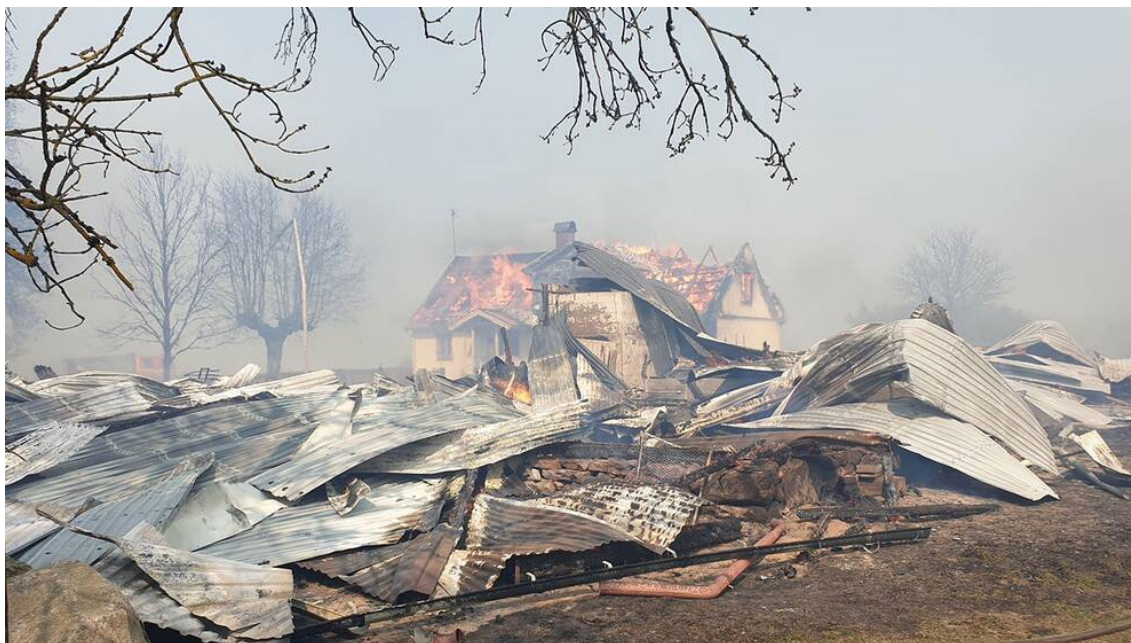
Figure 13. Collapsed stable (foreground) and burning dwelling (background) on the horse farm, 2019. Photo: Mikael Nilsson.

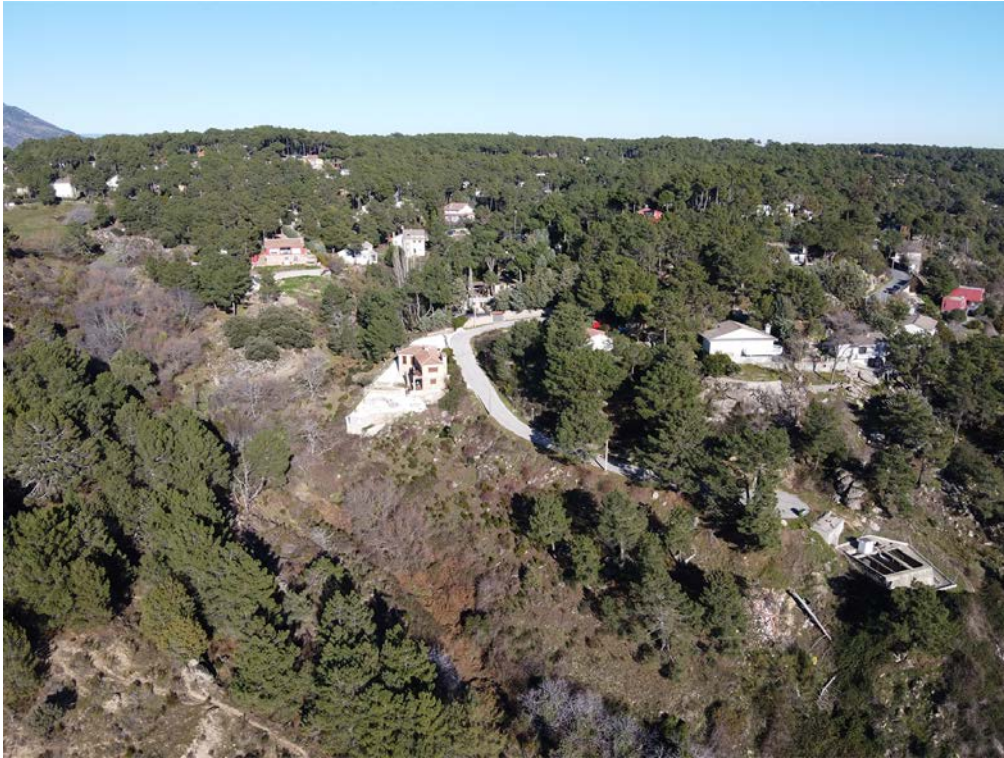
*Figure 15. A general view of the South limit of the settlement. Note that there is no separation between the forested area and the urban development.*

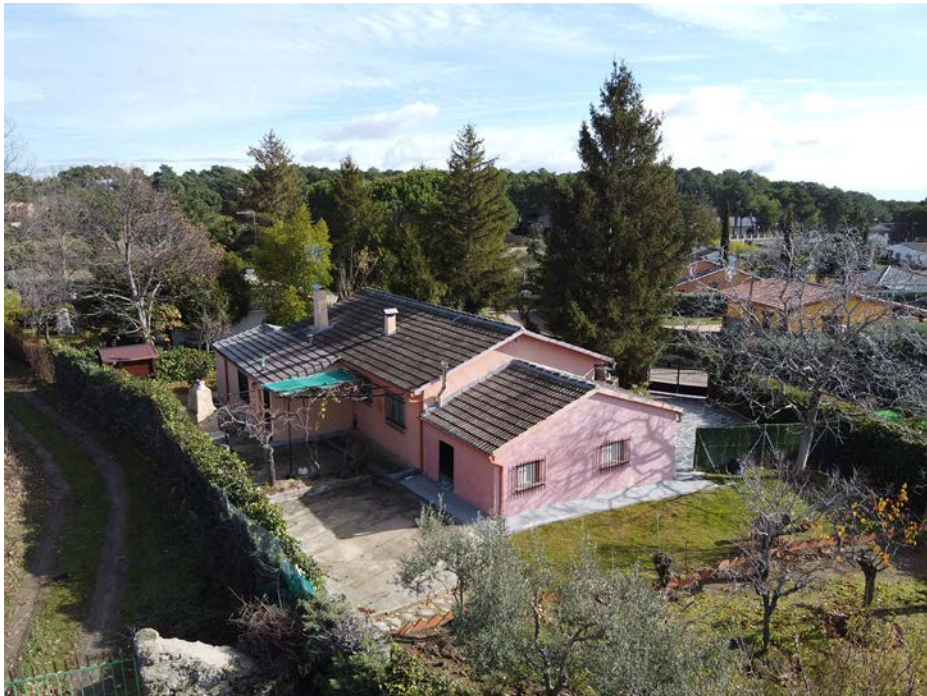
Figure 18. A general view of the West side of the study case. The green hedges are a mix of perennial and conifer (cypress) species. Note the cluster of trees in the East side and the pine stand behind.

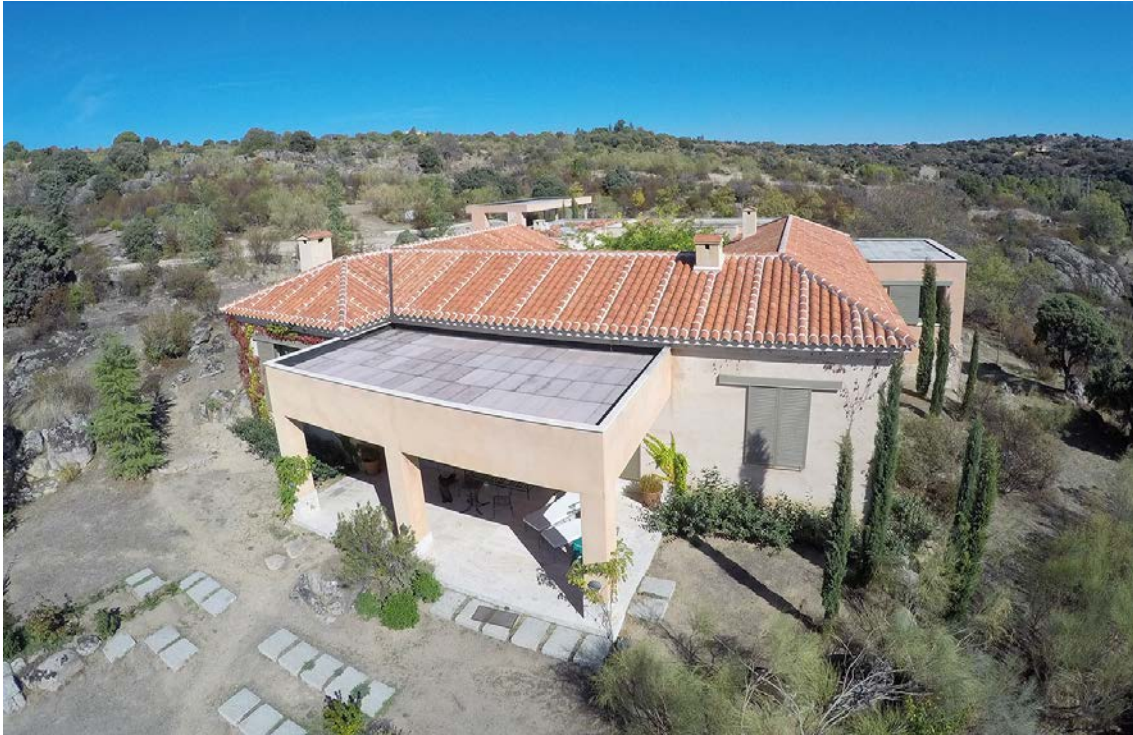
A porche is facing the South-West side and it is flanked by two large oak trees. Small vegetation is present around the house, in some cases touching the façade, and inside the patio. No other side structures, except a small one to protect cars from sunlight, are found in the property. Owner is very aware of fire risks, as well as other homeowners in the settlement, and is committed to proceed with prevention measures to improve chances of structure survivability in case of fire. All the family is aware of using the house as shelter, in case of entrapment, which is very likely given the only access to the urbanisation (Figure 41).

*Figure 41. A view of the South-East side with the porche and the surrounding vegetation. Note that some of the ornamental species are touching the façade. Also note the tree inside the patio*
