Technical Note TN 2.6. Forensic study of a burnt hedgerow of *Cupressus arizonica* in Las Rozas (Madrid)

Abstract	This Technical Note gathers the data obtained from a forensic study of a hedge burnt in Las Rozas municipality (Madrid). The comparison between the remaining fuels after the fire and a fuel sampling of the unburnt sections of the hedge shows the consumed fuel that contributed to the fire spread. The effects of the fire spread over the house have been also cataloged.
-----------------	--

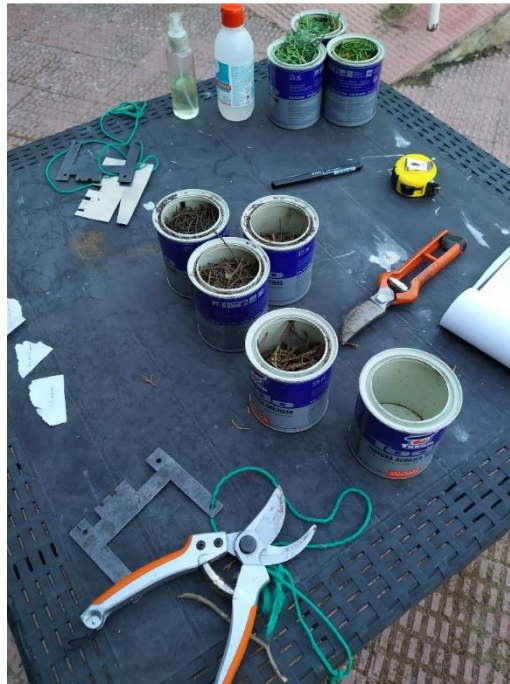
The fuel was collected at approximately the same hour at which the fire occurred (Figure 3). It was weighed *in situ*, stored in sealed cans, dried and weighed again to calculate its Fuel Moisture Content in dry basis (FMC_0). The weight was measured with a portable balance Mettler Toledo BL600 (0.1 g prec.). The samples were oven-dried for 24 hours at 90 degrees in a BINDER APT. line ED 720.

Figure 3. Sample collection for FMC_0 calculation.

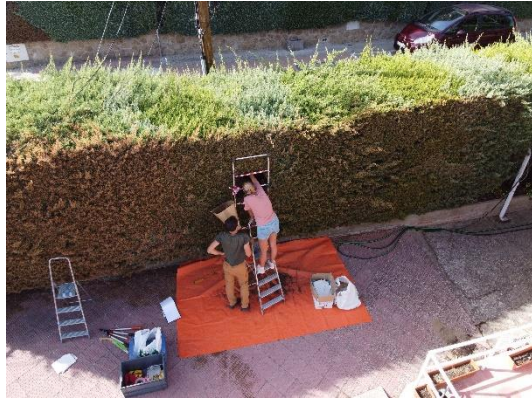
Figure 4. Process of collecting the fuel in the upper incision. Notice that the most external foliage was withered as a consequence of the exposure to radiation. The left site was the closest to the fire.

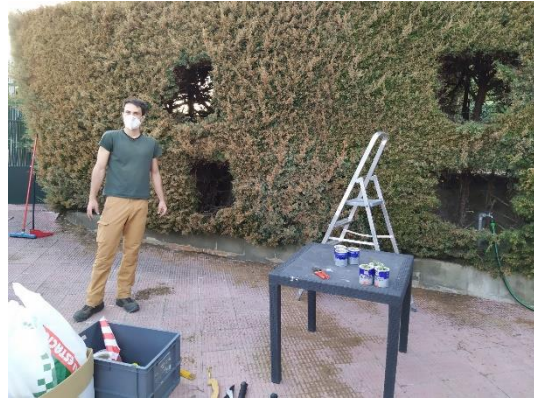
Two sites of the hedgerow were selected for the sampling of the living vegetation (Figure 3 & Figure 5). In each one of these sites, two incisions were made, centred 1 and 2 meters above the ground. The incisions were 0.5 meters wide per 0.5 meters high (0.25 m^2 of surface), and the depth was equal to the distance between the main stem of the hedgerow and the end of it (i.e. approx. half of the depth of the hedge).

Figure 5. Four incisions were performed in the hedgerow (left and right sites) at one and two meters of height. Notice the tap and the hose in the bottom incision of the right site.

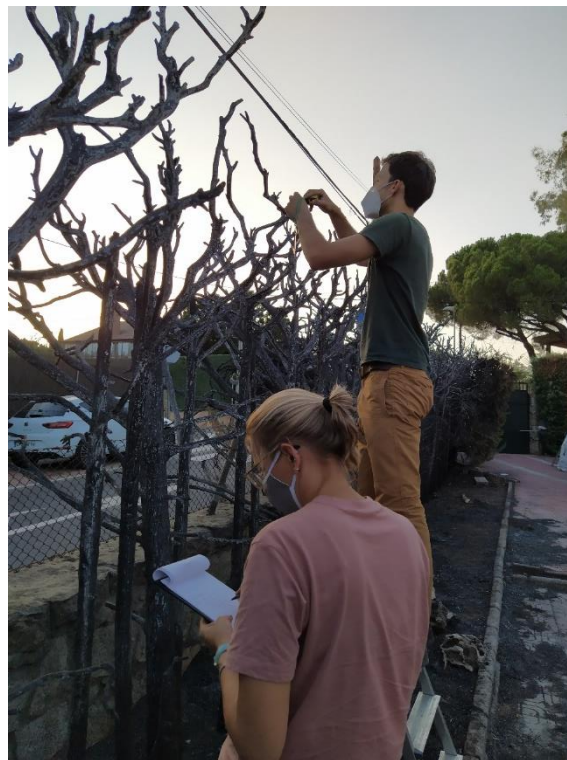
To estimate the amount of fuel that contributed to the release of energy during the event, the remaining materials of four burnt trees were sampled. The sampling consisted of the measurement of the diameter of the remaining branches: all fuels of the same branch, which were thinner than the measured diameter, were burnt during the fire (Figure 6).

Figure 6. Measuring of the final diameter of the remaining branches.

A total of 109 measurements were taken of the remaining branches of four trees of the hedgerow burned during the fire. These branches had an average diameter of 0.93 cm, with a standard deviation of 0.32 mm. These data imply that the branches around one centimetre of diameter are charred but not completely burned, and can be assumed to not contribute to the combustion.

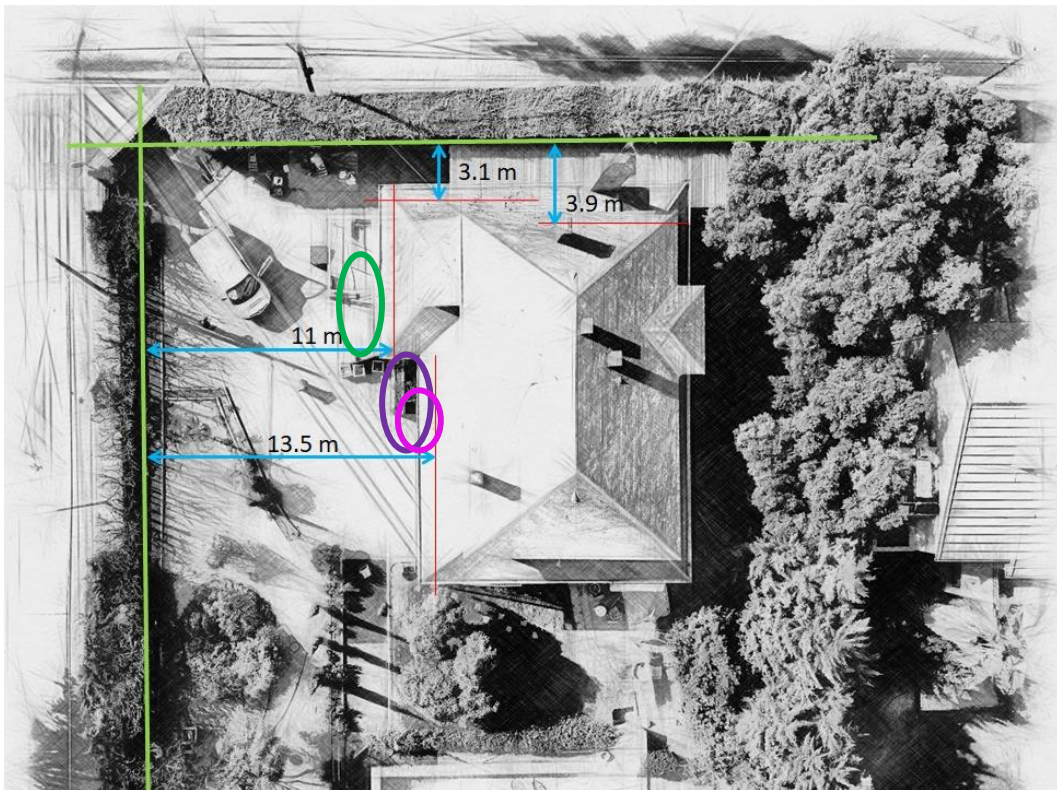
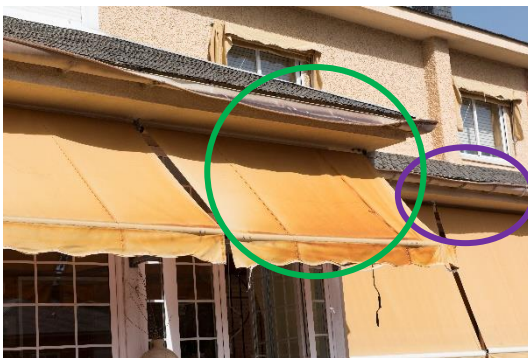
Figure 7. Effects of the fire over the elements of the house.

Awning: it remained unfolded during the fire. The section 11 meters far from the hedge was scorched, but not the section at 13.5 meters.

PVC Gutter: both sections (11 and 13.5 meters far from the hedge) warped. This deformation was light at the background, but severe at the closets section.

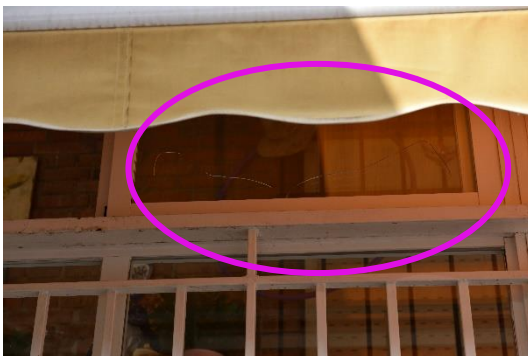
Windows: just one window cracked (but did not break) at 13.5 m from the hedge. The area of the window that cracked was not sheltered behind the awning. Other windows closer to the fire remained unbreak.
