Wildland-Urban Interface Virtual Essays
Workbench
WUIVIEW

Technical Note TN 7.2. Structure survivability in Swedish wildfires

WP - Task	WP7 T1	Version ⁽¹⁾	
File name	TN7_2 Structure survivability Sweden	Dissemination level ⁽²⁾	Internal
Programmed delivery date	31/01/2021	Actual delivery date	31/01/2021

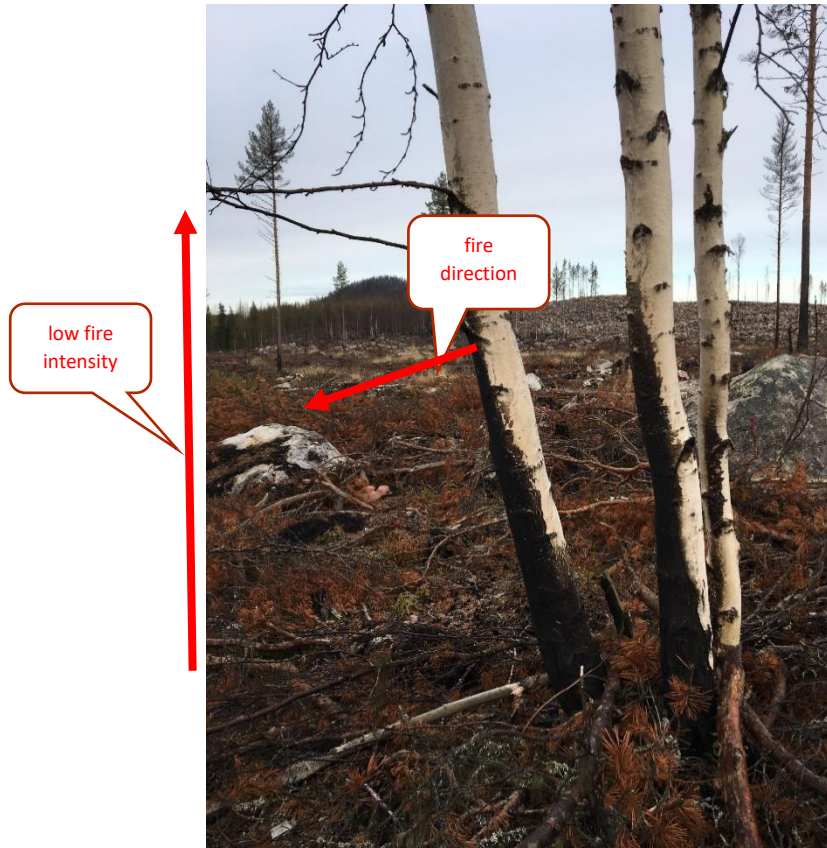
Figure 3. Indications of local fire intensity and fire direction

Isochrones from satellite images provide time stamps for the extending fire area, as well as indications of location of the fire front, flanks and backing fire at community level. Characteristics at the property level is indicated by local fire patterns. Fire intensity approaching a construction is e.g. suggested by scorch height in the adjoining wildland (Figure 3). In a similar manner is local fire direction indicated by soot and char angles on boles.

The most likely cause of ignition of structures has been assessed by analyzing destruction patterns in the surrounding area of each building. Unconsumed vegetation and unburned structures nearby indicate firebrands as a likely ignition source, whilst low fire intensity in combination with a fully consumed surface vegetation indicate ignition by flame contact (Cohen, 2000).

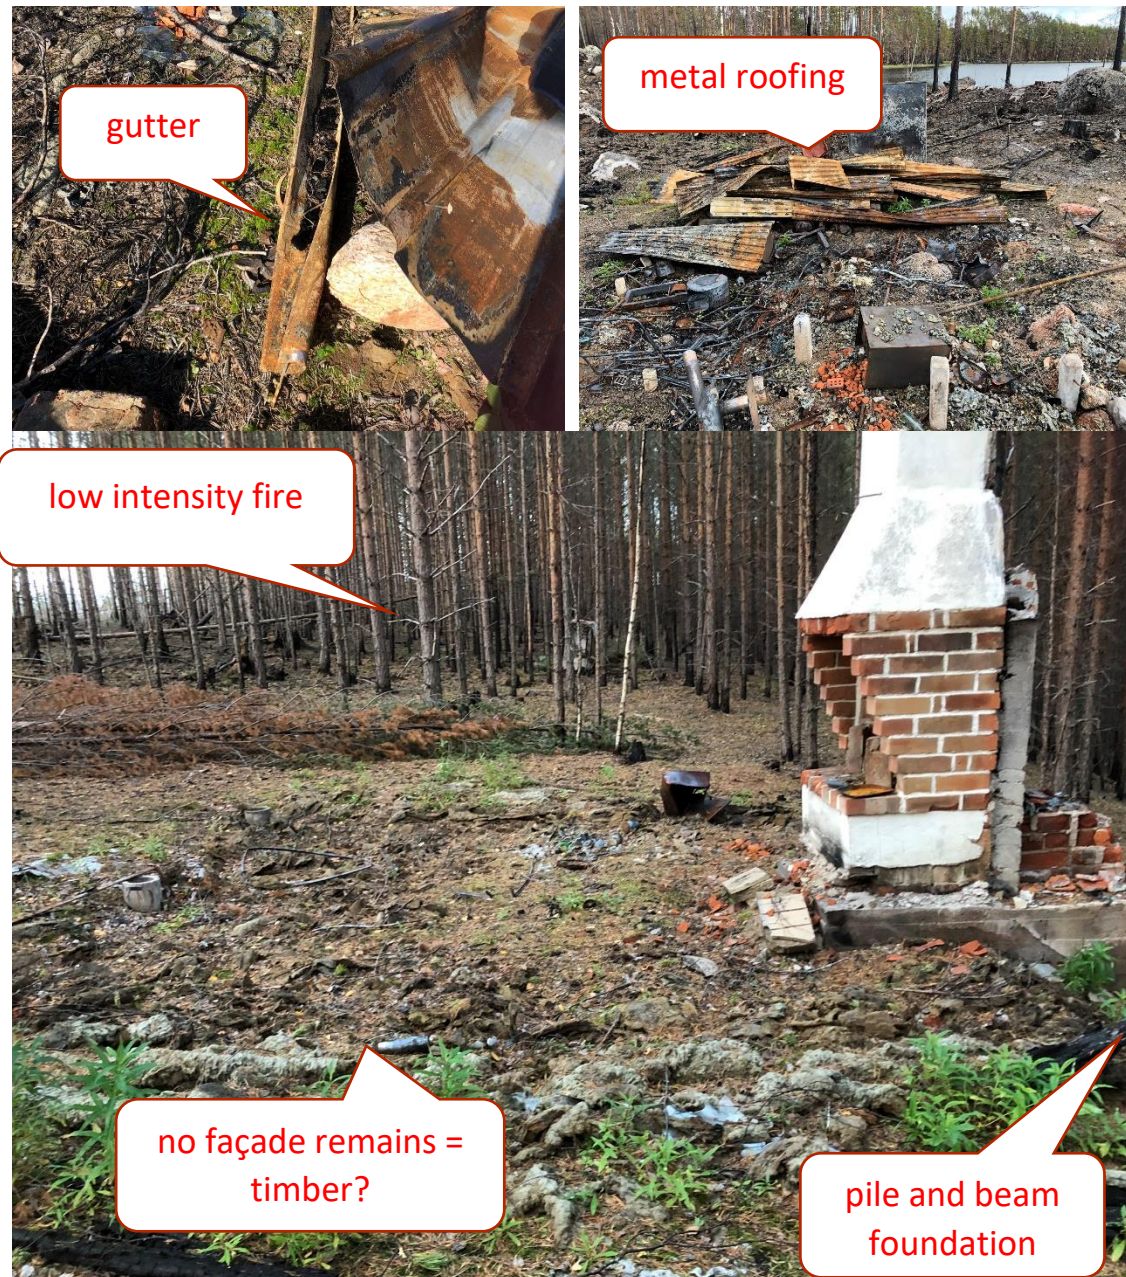
Figure 4. Example of the Inventory of destroyed structures

Information about the structures are obtained in a combination of an inventory at the fire sites (Figure 4), interviews with and photos from house owners and personnel working during the incidents. Uncertainties (e.g. lack of remains) are as far as possible double-checked with the house owners.

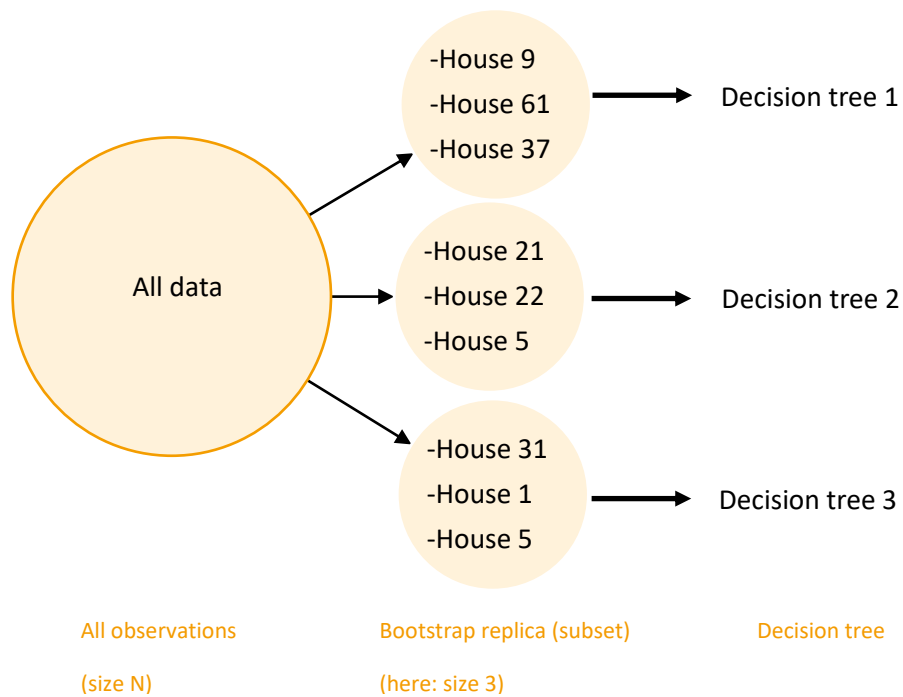
Figure 6. Generation of bootstrap samples

observational data (called bootstraps) to build decision trees, Figure 6. The observational data which is not selected by a bootstrap replica is referred to as out-of-bag data. These observations are subsequently used to calculate the prediction accuracy of the built model.

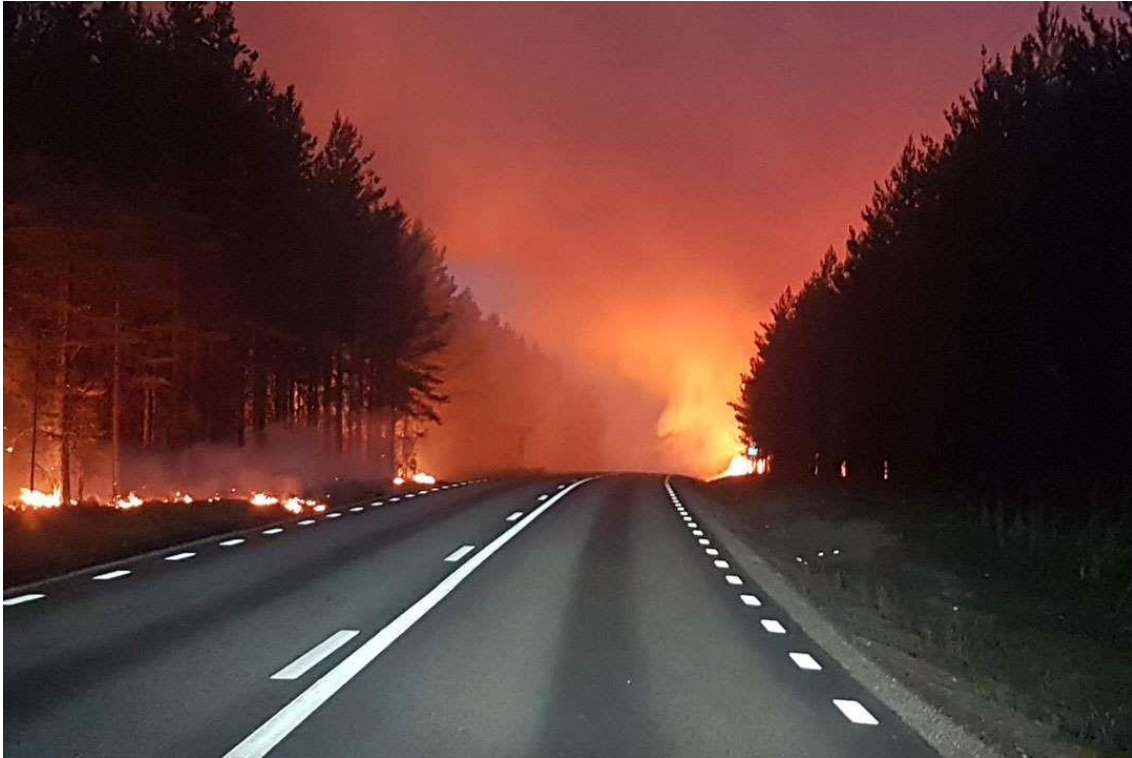
Figure 9. Ängra fire. Photo by Marco Hassoldt.

Whilst the closer investigated fires partly burned with high intensity, most of the fire patterns in the vicinity of structures indicate a primarily low intensity (79 % of the cases, compared to 11 % medium and 11 % high). An example of low fire intensity in Ljusdal is seen in in the left of Figure 9

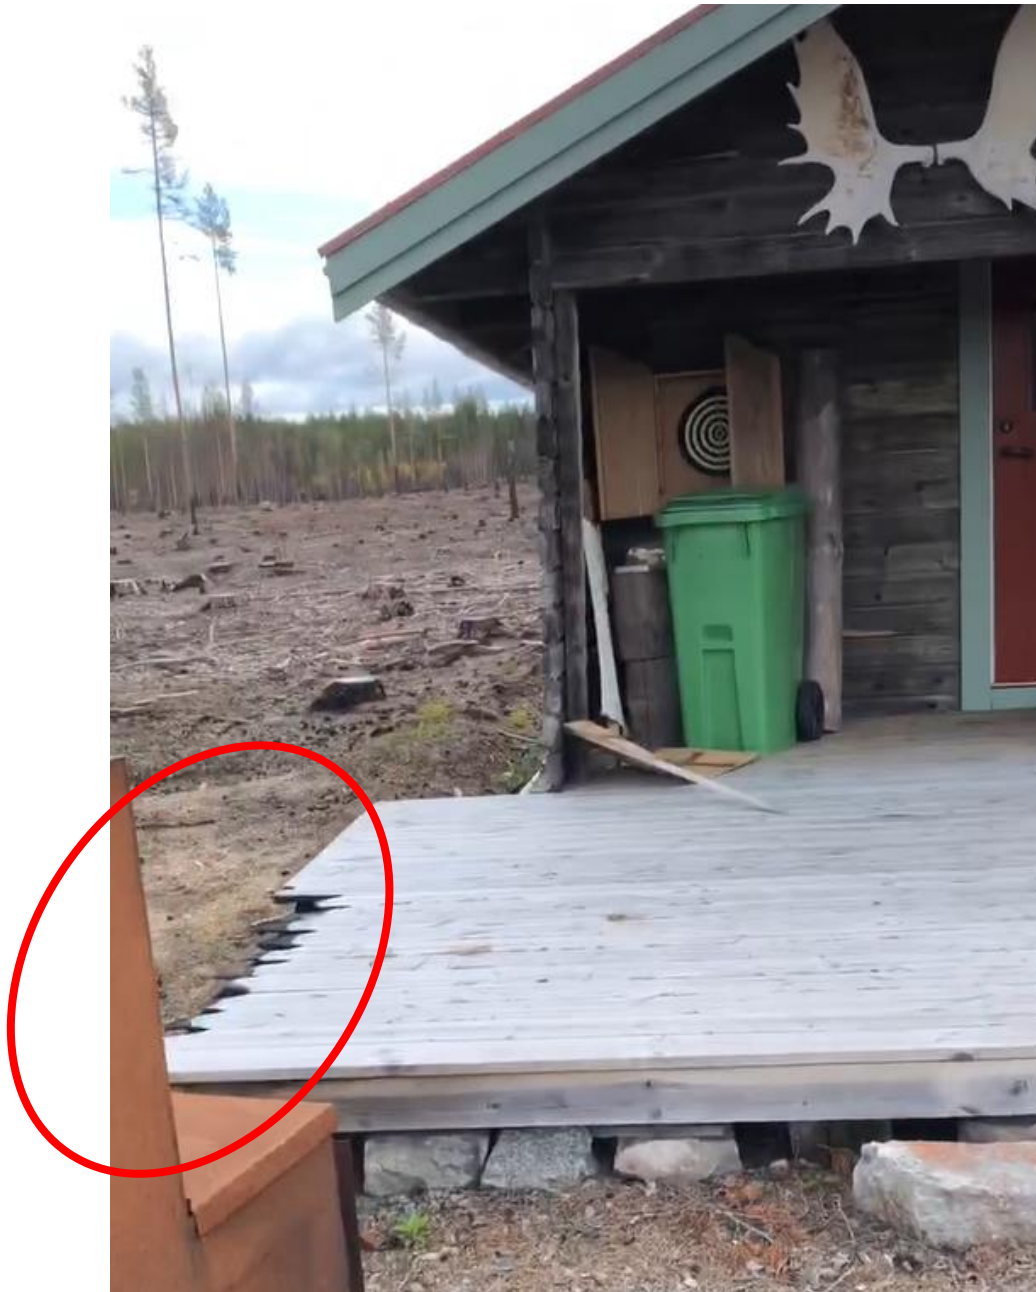
Figure 10. Example of low-intensity fire ignition by flame impingement of a wooden deck, in this case followed by extinction.

However, the availability of a continuous fuel bed from wildland (sometimes via garden) to the façade was characteristic of the fires, in many cases carrying the low-intensity fire all the way to the building foundation. Structures are mainly ignited due to flame impingement rather than glowing embers or sparks carried by wind. The phenomenon is exemplified in Figure 10 and Figure 11.

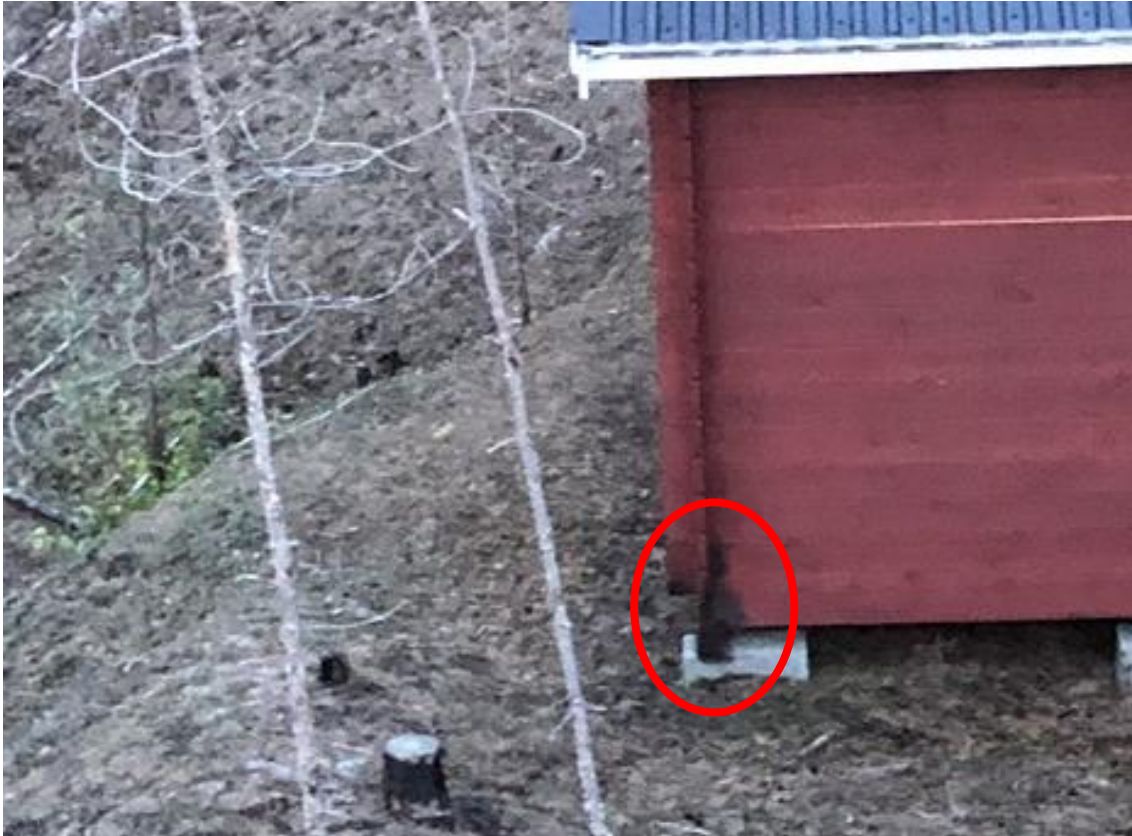
Figure 11. Example of low-intensity fire ignition by flame impingement of the façade, in this case followed by extinction. The vegetation around the structure (below the cover of pine needles) is fully consumed.

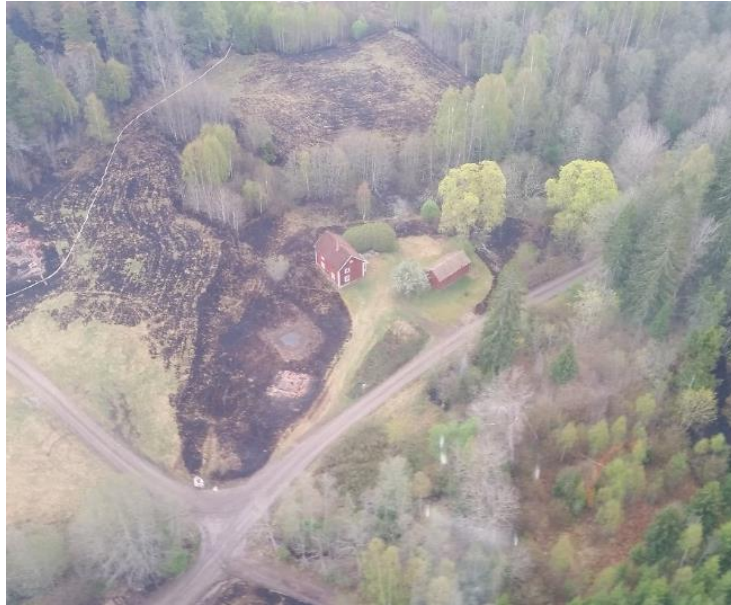
Figure 13. An example in which a low-intensity fire in a maintained lawn has carried the fire to the dwelling without subsequent ignition. The maintained lawn has prevented the fire to be carried to the outbuilding. Photo: Anders Granström.

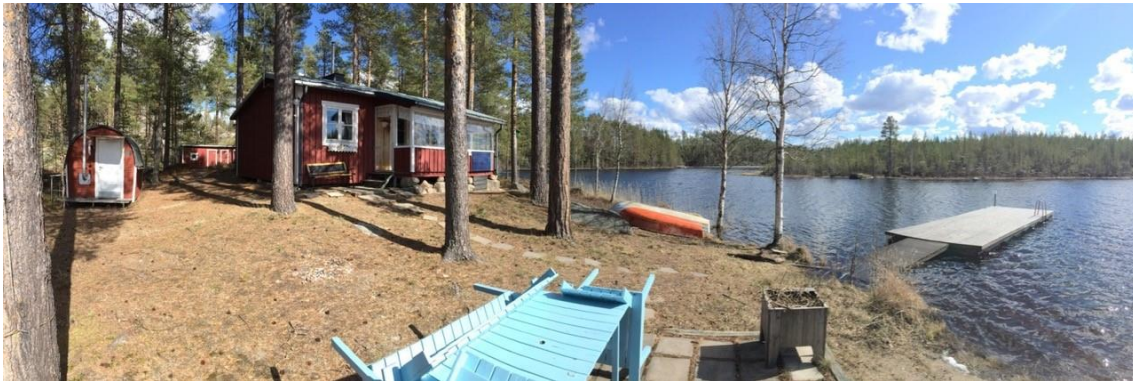
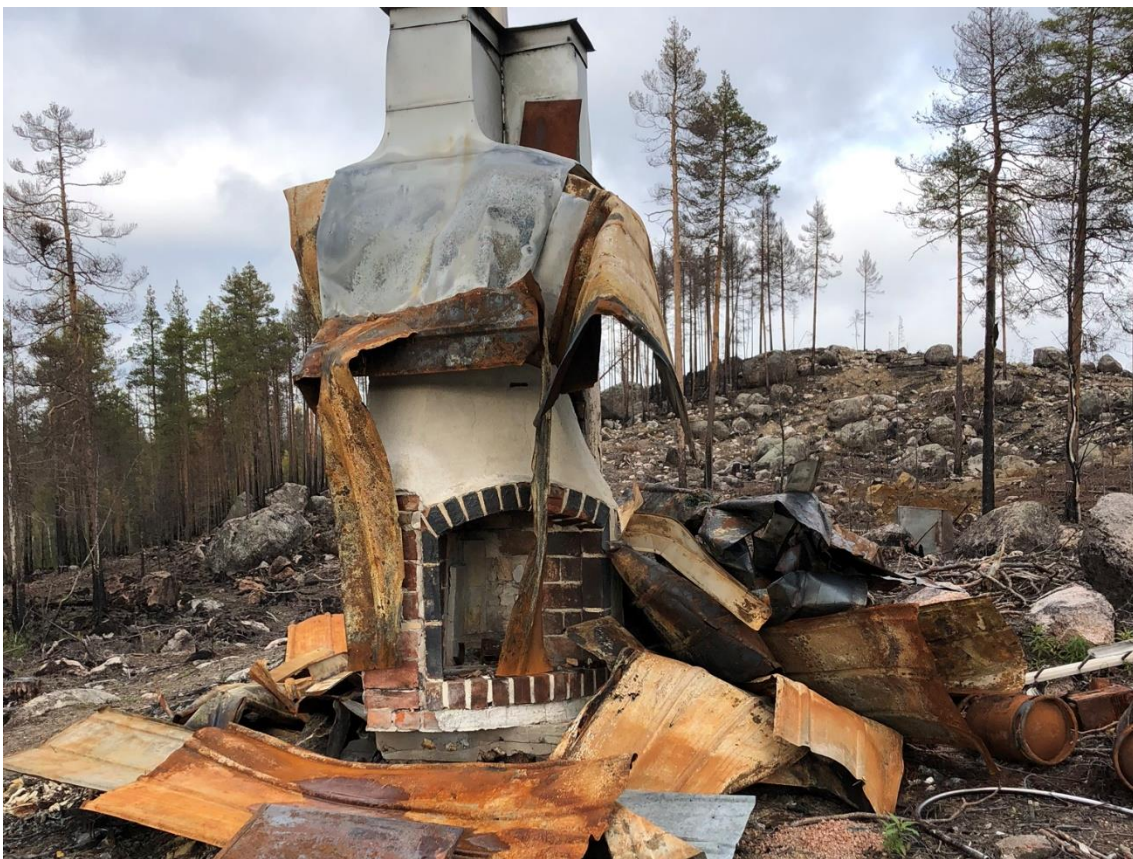
Figure 15. Summer house with a sauna and an outbuilding: (upper) prior to the fire, and (lower) one year after the fire. Upper photo by Johan Molarin.

An example of a forest garden for a summer house is seen in Figure 15.

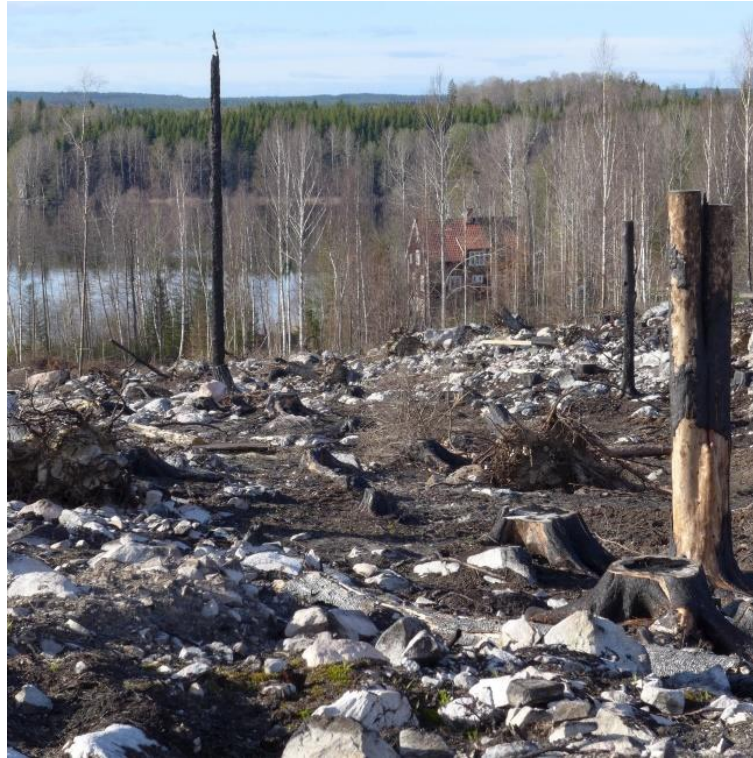
Figure 17. After the Västmanland fire, April 2015. The foreground shows what previously was a vegetated clear-felled area. The trees on the clear-felled area as well as surrounding coniferous forest burned with crown fire. However, the deciduous forest strip containing birch, willow and aspen stopped the fire before it reached the structure in the background. Photo by Kenneth Risberg.

Vegetation and land type surrounding the building can be shown to play a role for survivability. The vegetation type in a semi-circle of 40 m radius in the direction towards fire are shown in Figure 17 for the structures in the Ljusdal fires. The close presence of roads increases survivability as does a surrounding forest with inclusion of broadleaves compared to only pine or mixed conifers. Buildings close to a clear-felled area (temporarily non forest in Figure 17) were all destroyed in the fires.

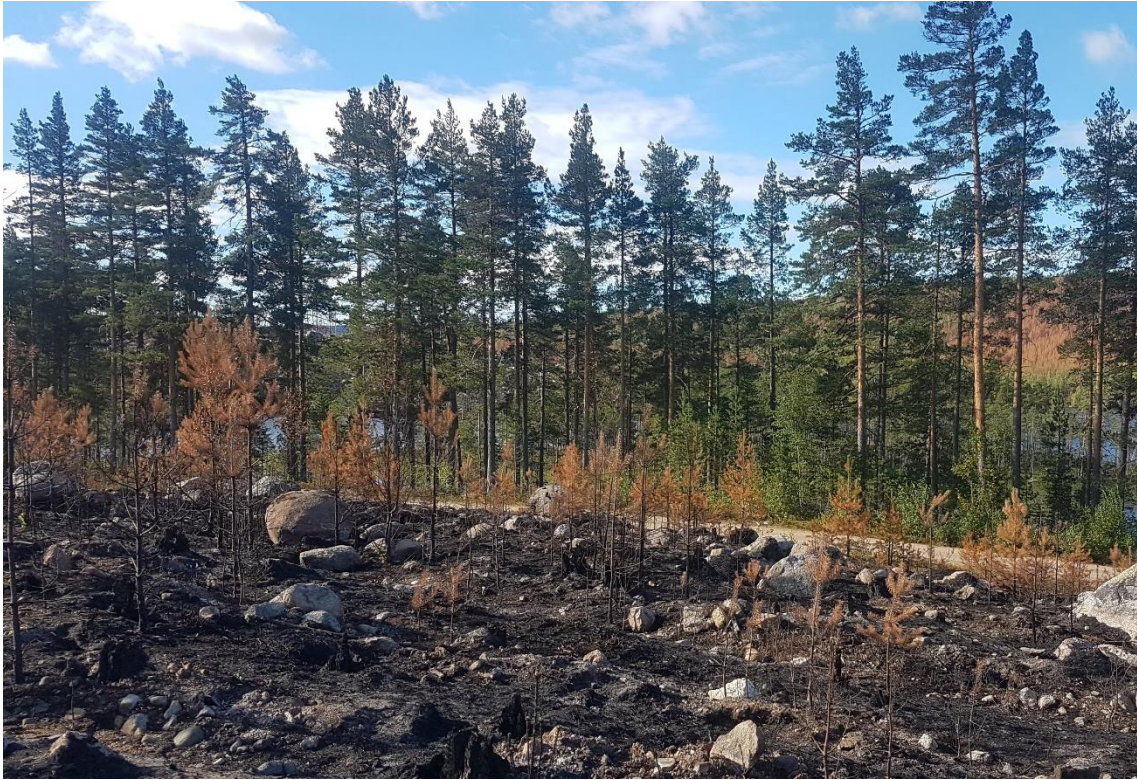
Figure 18. Forestry road as a functioning firebreak, where the fire did not carry over. Photo: Marco Hassoldt.

Even though firebreaks, such as roads, is not statistically significant for survivability in this data we also see a that roads between building and fire is more common for the surviving structures. Two examples of functioning firebreaks are given in Figure 18 and Figure 19.

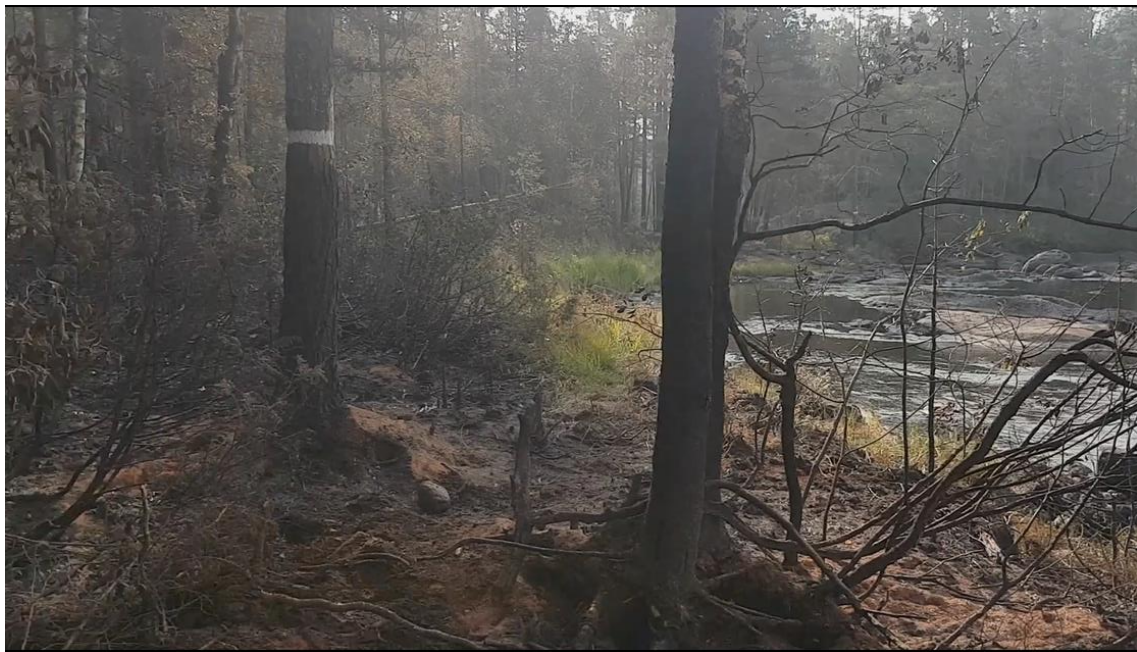
Figure 19. Watercourse as a functioning firebreak. Photo: Marco Hassoldt.

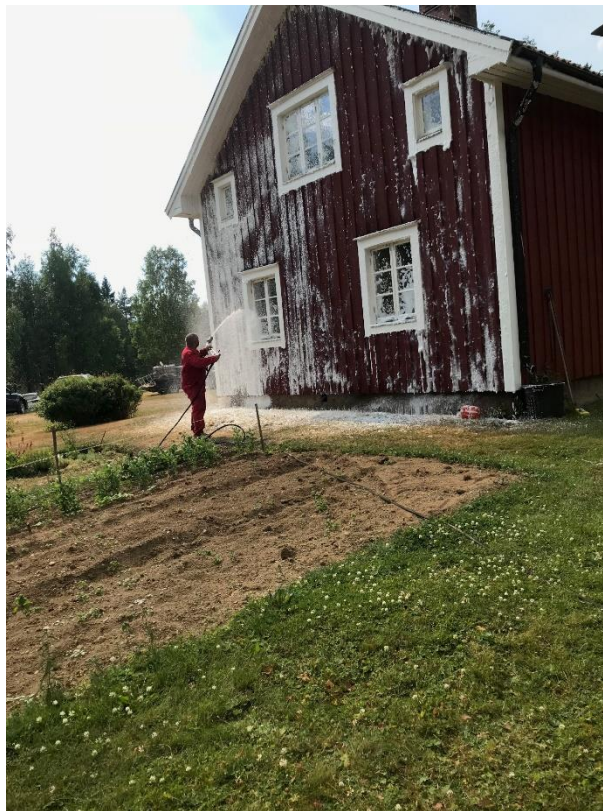
Figure 20. Preventive foam deflection of a structure. Photo by Anna Eriksson Swenne.

There has not been any data collection on where mitigation efforts by the rescue service may have saved structures, since there is uncertainty of whether and when such actions would have been conducted. In the Ljusdal fires, two cases are found; one where water bombing was evidenced by structure damage, and one structure where there is photographic evidence of preventive actions (Figure 20), although this was the only case that the interviewed fire fighter knew about.
