Wildland-Urban Interface Virtual Essays  
Workbench  
**WUIVIEW**

## Deliverable D7.2 Report on case studies

<b>WP - Task</b>	WP7 – Tasks 7.2 and 7.3	<b>Version <sup>(1)</sup></b>	Final
<b>Code (file name)</b>	D7.2_F_WUIVIEW_Report on study cases	<b>Dissemination level <sup>(2)</sup></b>	Internal
<b>Programmed delivery date</b>	31/01/2021	<b>Actual delivery date</b>	31/01/2021

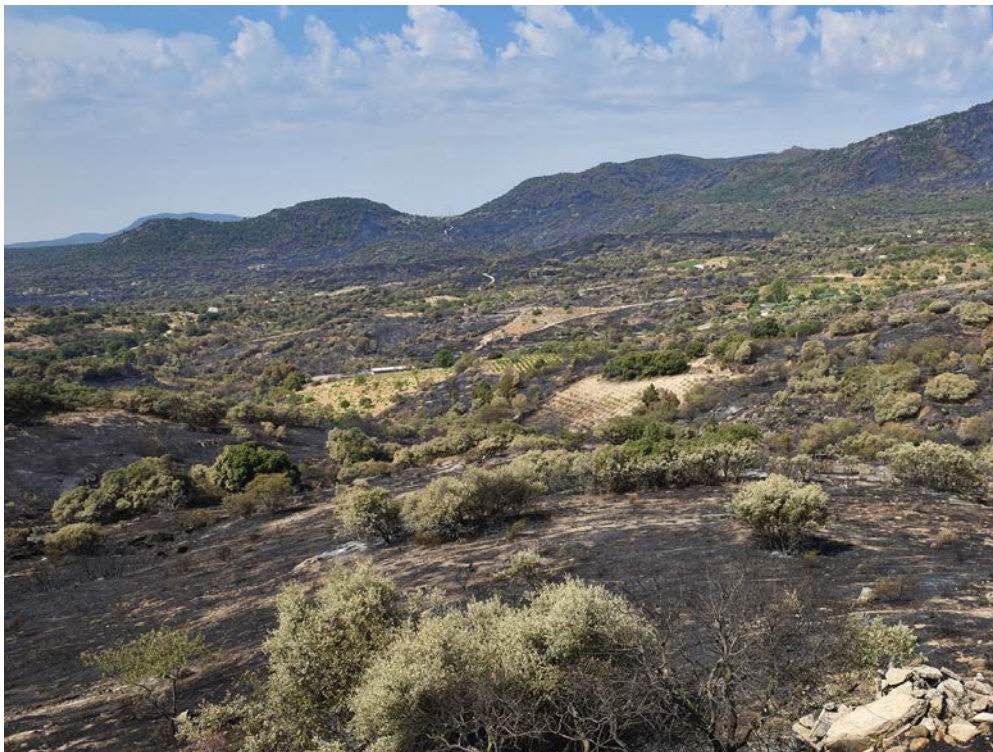
*Figure 16. A general view of the fire scar in Cadalso de los Vidrios, in July 2019. This is a fire-prone area with recurrent fire events. In the right of the image, several affected pine stands show very intense fire behaviour.*

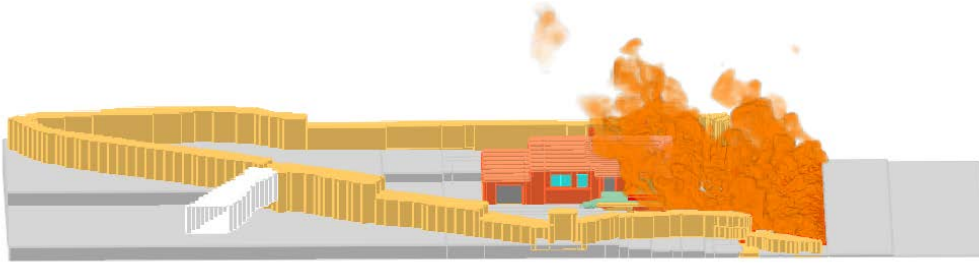
Figure 30: Entrepinos - Scenario low frequency, high consequences at 10 s

In scenario 1 the flames engulf the east façade and part of the south façade through the porch, as can be seen in Figure 30. This means that the flames are covering a horizontal distance of about 10 m.

The four windows located the closest to the fire source failed very soon after the start of the fire, as given in Table 19.

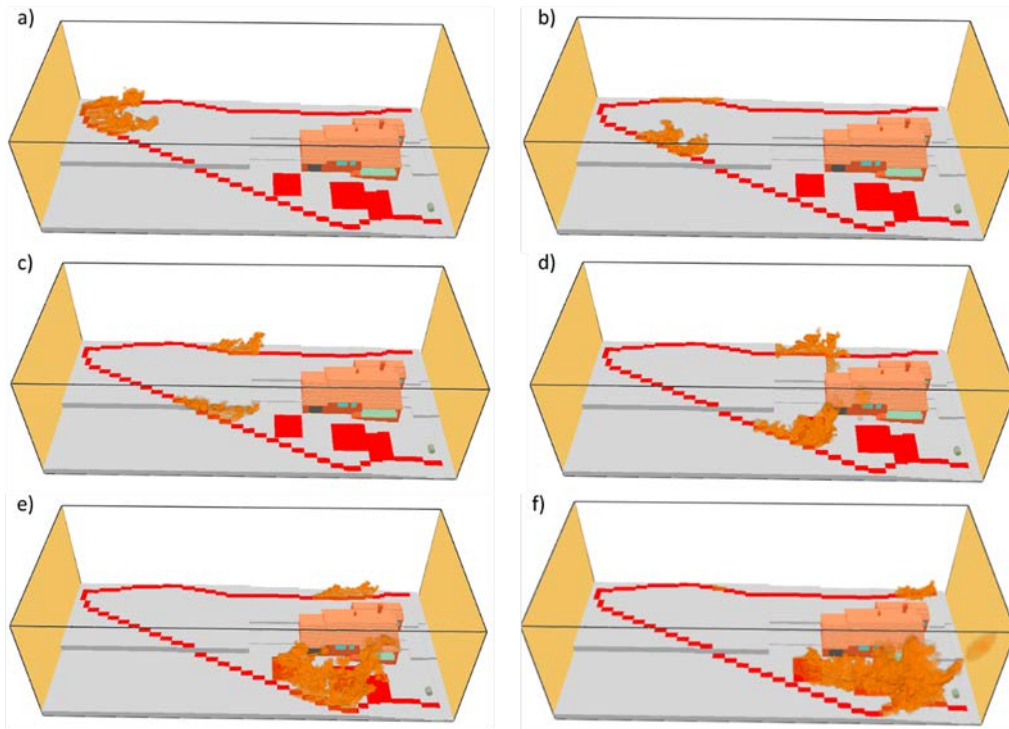
Figure 31: Entrepinos - Scenario 2 at 20 s (a), 40 s (b), 60 s (c), 80 s (d), 100 s (e), 120 s (f)

Figure 31 shows the fire spread through the property over time for scenario 2. As shown in Table 20, only the windows located on the southern façade failed, due to the ignition of the trees located on that side of the property.

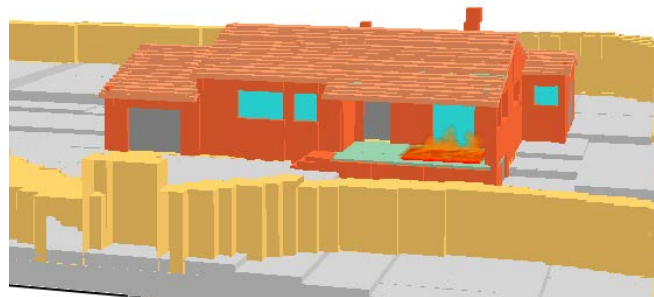
Figure 32: Entrepinos – Scenario 3 at 250 s

Figure 32 shows the combustion of the fuel pack on the porch at 250 s. As given in Table 16, the only glazing system that fails in this scenario is the one located on the porch, which is also the closest to the fire. Failure of the glass will happen before the fire reaches its peak HRR value.

This scenario cannot be deemed safe for both property protection and life safety due to the failure of the glazing system located on the porch.

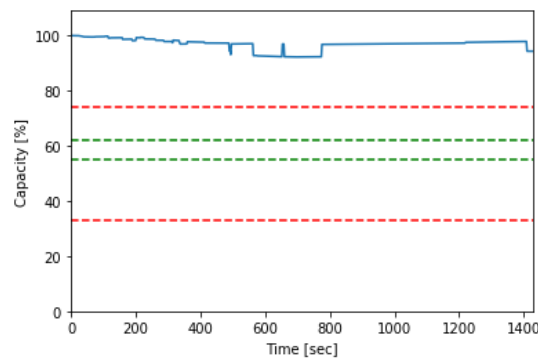
Figure 33: Load bearing capacity of the wall over time

Given the semi-confined characteristics of the porch, an analysis of the load bearing capacity of the walls of the porch is also performed. Temperature profiles through the wall located to the left of the window are measured during the duration of the fire. As can be seen from the blue line in Figure 33, the load bearing capacity of the wall never falls below 74%.

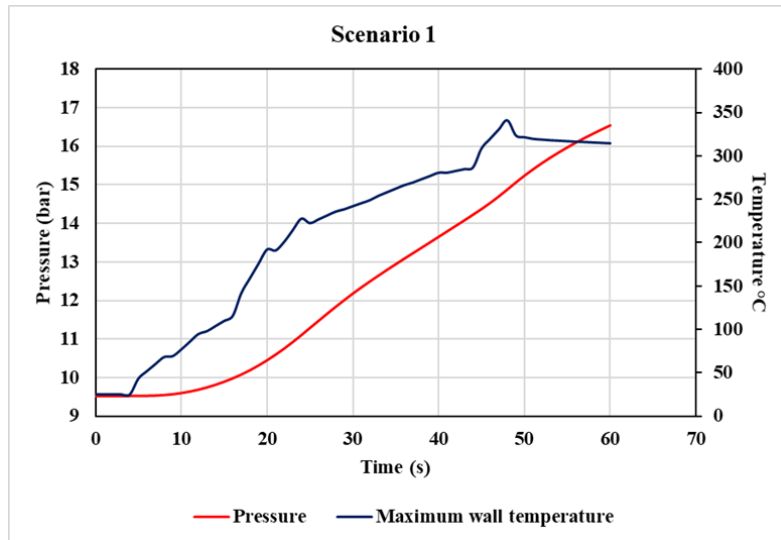
Figure 34: Pressure evolution inside the tank and tank wall temperature

The incident heat flux onto the tank is greater than 22 kW/m<sup>2</sup> already after 1 s of the simulation. Further investigation with ANSYS Fluent shows that the Pressure Release Valve Index is 0.9, while the temperature of the tank walls remains below the critical value of 400°C, resulting in a null Weakened Surface Index (Figure 34). It can be concluded that this scenario does not have the potential to compromise the integrity of the LPG tank. However, it may lead to the opening of the PRV, which, is an unwanted situation.

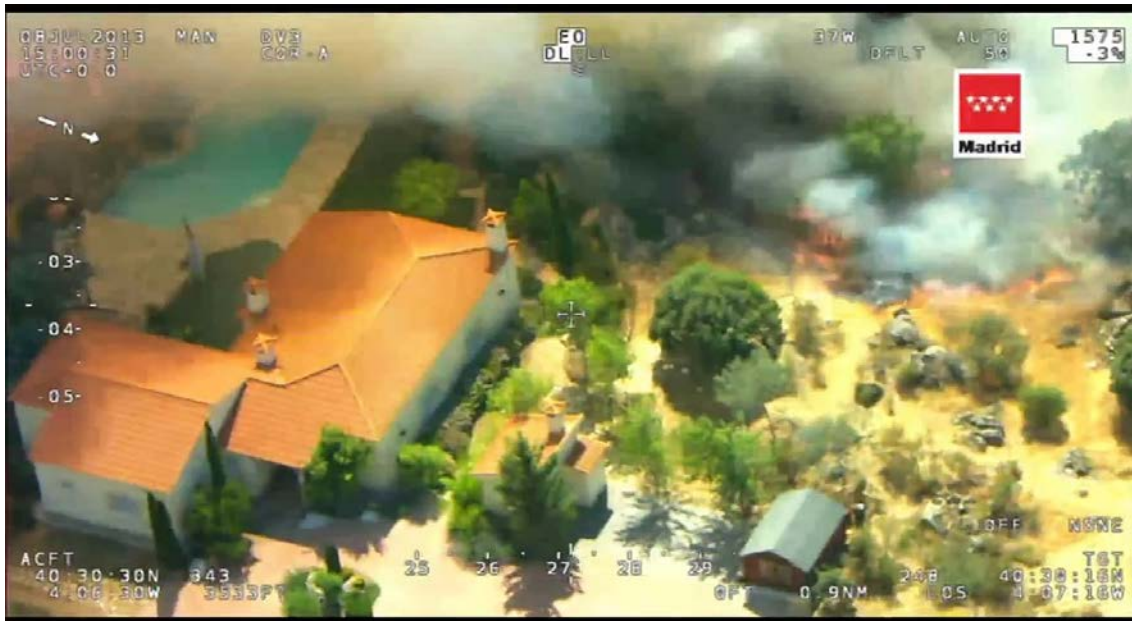
Figure 37. One of the houses threatened by the approaching fire in the event of 2013. The fire started in one of the properties in Los Barrancos and quickly expanded towards other nearby settlements. All population was evacuated to the town of Valdemorillo.
