<p>Wildland-Urban Interface Virtual Essays Workbench</p> <p>WUIVIEW</p> <p>GA number 826522</p>	 	  <p>Funded by European Union Civil Protection</p>
---	---	--

Technical Note

Wildfires in 2020

Forest Fire in Eurovillas - Madrid (Spain)

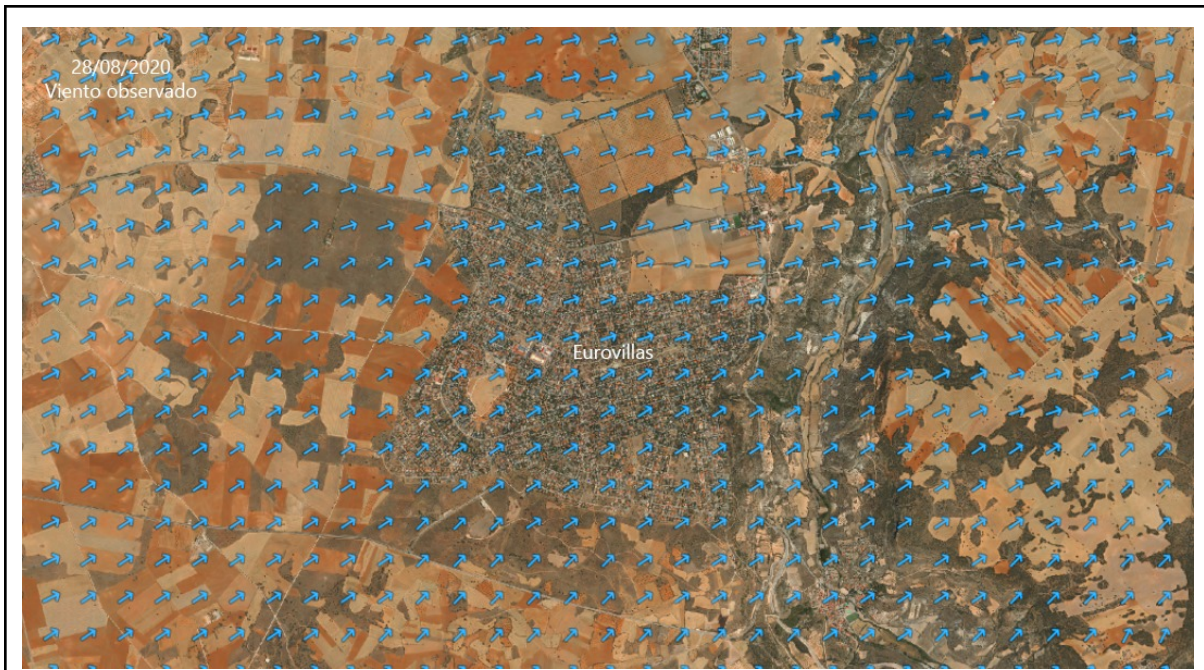
General component of wind in the moment of the fire event, as extracted from the official meteorological service (AEMET). The wind direction stayed constant over the whole episode.
